**SEA COAST  
MANAGEMENT NO. 3., INC.  
STRUCTURAL INTEGRITY RESERVE  
STUDY (SIRS)**

**For 30-Year Projection Period: FY 2023 through FY 2053**

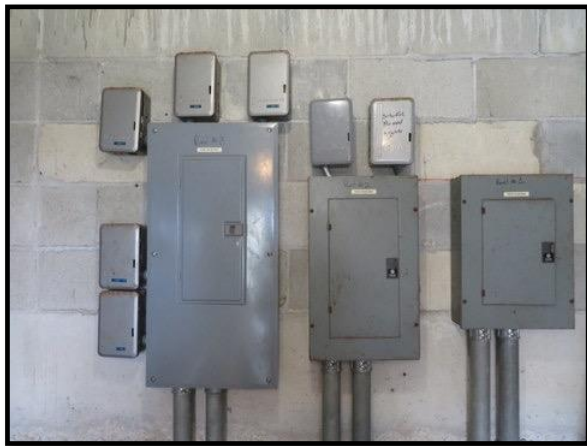
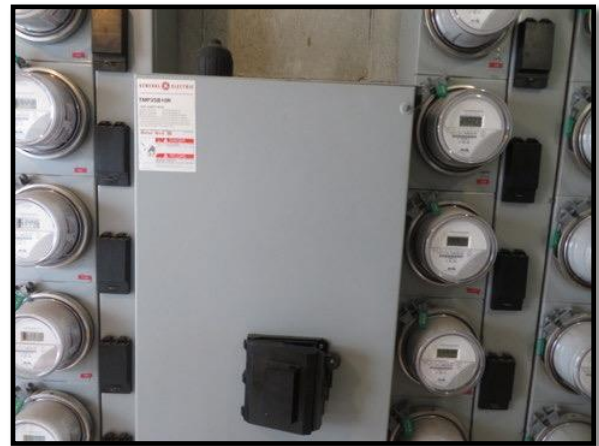
The Association maintains the common electrical systems. The common area main electrical panels are primarily original, in satisfactory operational condition and range in capacity from 100- to 1,000-amps. Electrical systems have a long useful life of up to 75 years and beyond. Not all components will fail simultaneously and therefore periodic repairs and partial replacements are likely as the system ages. The Association should budget for partial replacements by 2026 and every 10 years thereafter. The exact times and costs will vary.

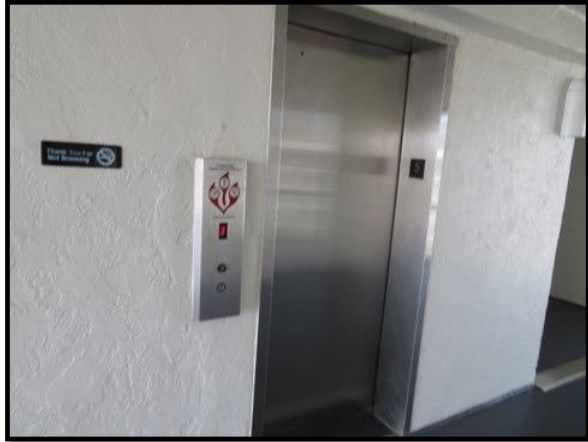
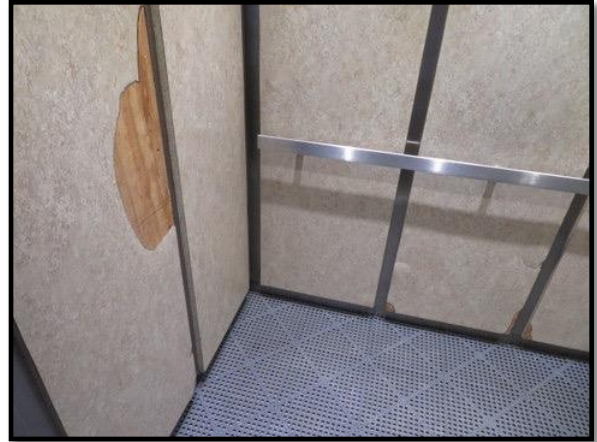
The Association maintains two elevators. The cab finishes comprise tile floors, lighted ceiling and wood panel walls. The cab finishes and doors are in fair condition at an age of eight years. Cab finishes and doors have a useful life of up to 15 years. The Association should budget for these replacements by 2030.

Figure 1 – Door

Figure 2 - Elevator Cab Finishes

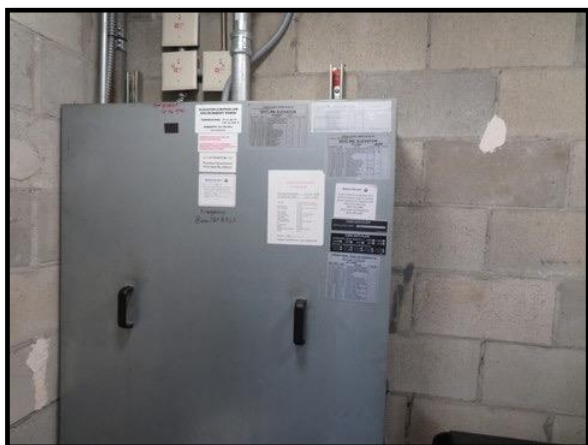
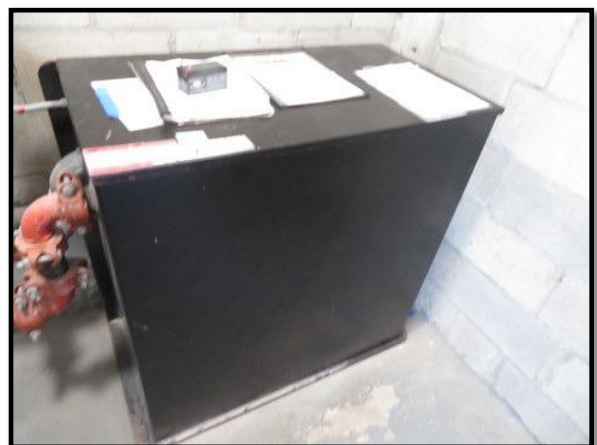
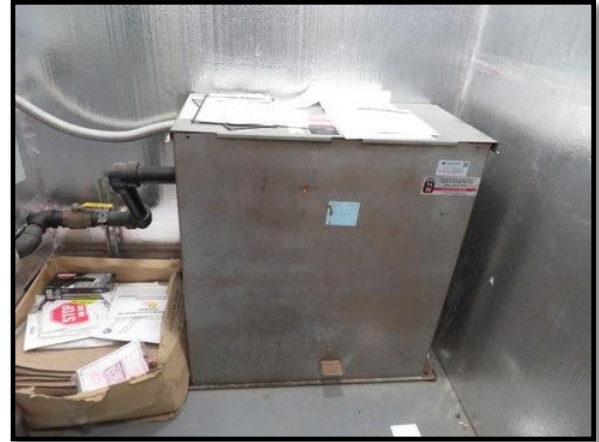
The Association utilizes two 2,000-pound capacity hydraulic elevators to serve five floors. Hydraulic elevator components include a cylinder, pump and controls. These components are in fair overall reported condition. The useful lives of these components vary up to 30 years. However, the Association should budget for a modernization of all the elevator components by 2043. Fire service features should be brought up to accordance with the requirements of the applicable ASME A17.1, Safety Code for Elevators and Escalators. The Association should contract with an independent elevator consultant to develop specifications for elevator replacement proposals.

Figure 3 – Elevator Controls

Figure 4 – Elevator Pump

Figure 6 - Elevator Pump

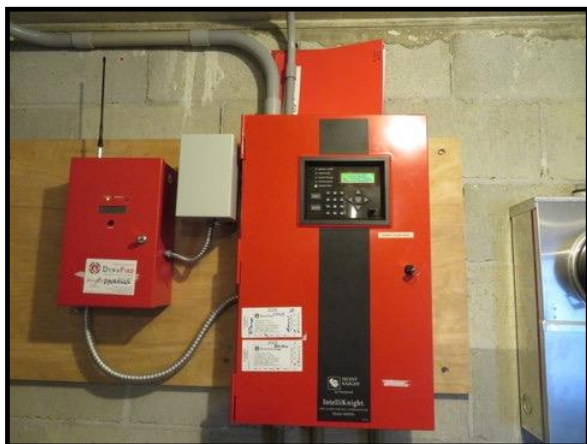
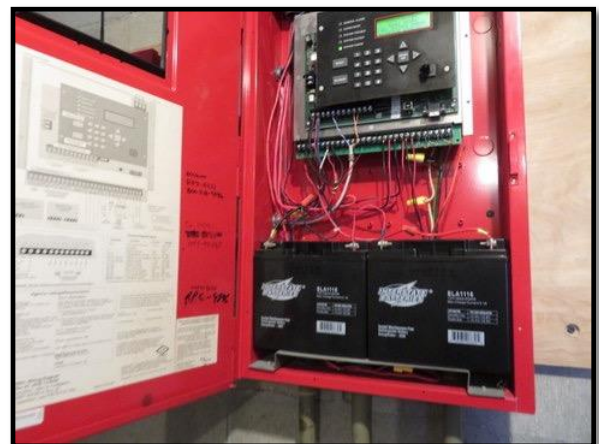
The Association maintains a fire protection system for each building. A fire protection system comprises a main panel that controls emergency devices such as annunciators and pull boxes. The system utilizes a battery backup. The fire protection system is in satisfactory operational condition at an age of approximately seven years. Changes in building codes and/or technology may make a replacement necessary and/or desirable prior to the useful life of up to 25 years. Sea Coast No. 3 should budget for replacements by 2041. Annual fire protection system inspections are required by the National Fire Protection Association (NFPA) 72 Standards. The Association should fund interim replacement of exit signs and smoke detectors through the operating budget as needed.

Figure 1 – Control Panel

Figure 2 - Control Panel

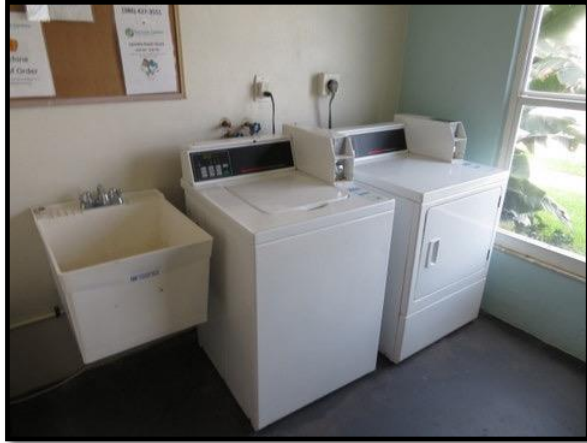
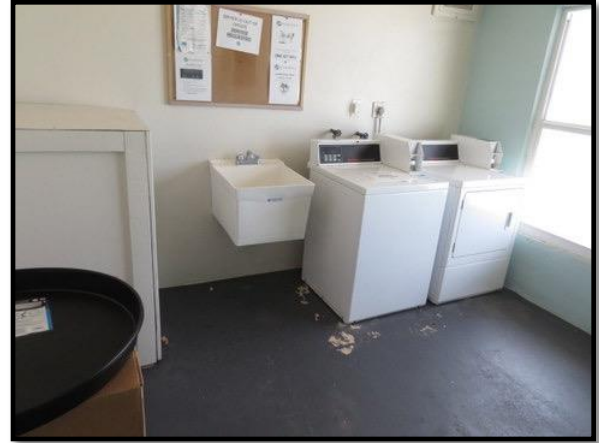
The Association maintains two pairs of washers and dryers on each floor. The laundry equipment is in satisfactory operational condition at an age of four years. Laundry equipment has a useful life from 5- to 10-years. Sea Coast No. 3 should budget for replacement of the laundry room equipment by 2025 and every seven years thereafter.

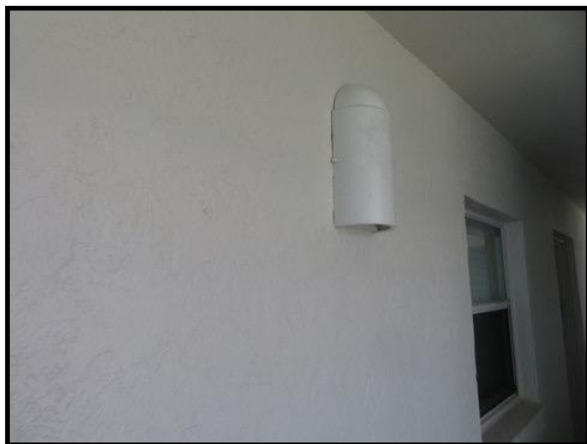
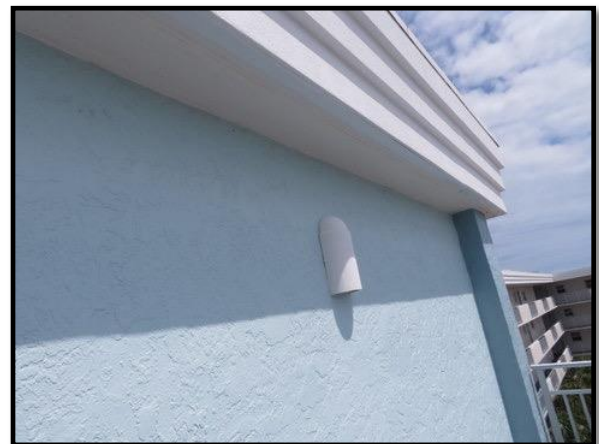
The Association maintains 246 exterior wall mounted light fixtures. The light fixtures are in fair condition at an age of 13 years. Light fixtures of this type have a useful life of up to 25 years. Sea Coast No. 3 should budget for replacement of the light fixtures by 2036. The Association should consider replacements with light emitting diode (LED) technology.

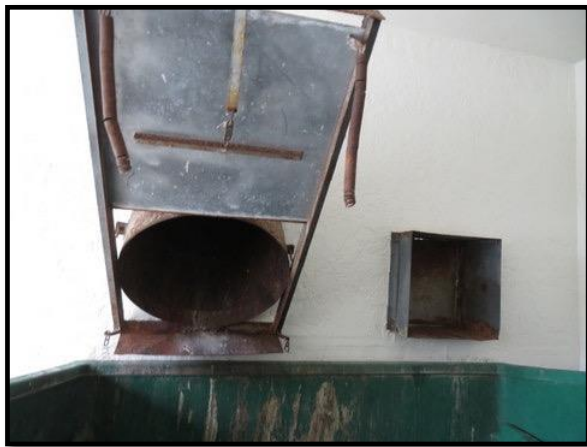
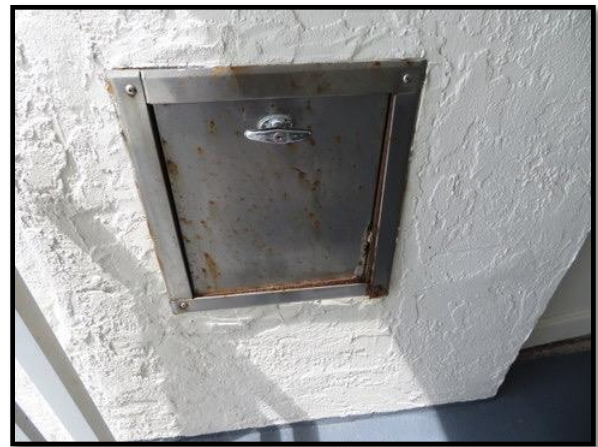
Sea Coast No. 3 utilizes a trash chute. The trash chute is original and in fair to poor condition overall. Areas of rust located at the bottom are noted. Trash chutes in coastal areas have a useful life of up to 55 years. The Association should pressure wash the chutes annually through the operating budget to maximize the useful life. Sea Coast No. 3 should budget for partial replacement of the bottom section in 2024.

Figure 1 – Chute End

Figure 2 – Typical Door

The estimate of cost includes modifications to the walls and replacement of the doors on each floor. The trash chute should meet the latest NFPA 82 standard.

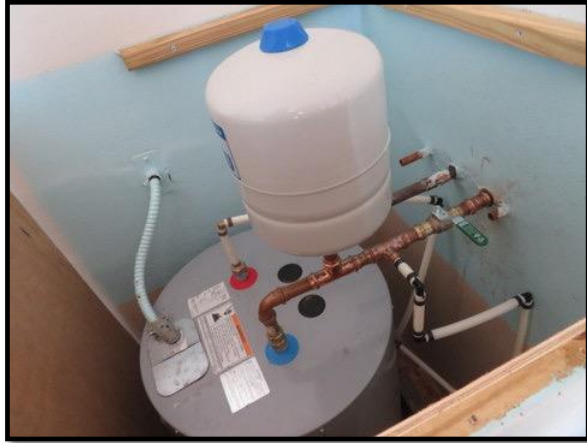
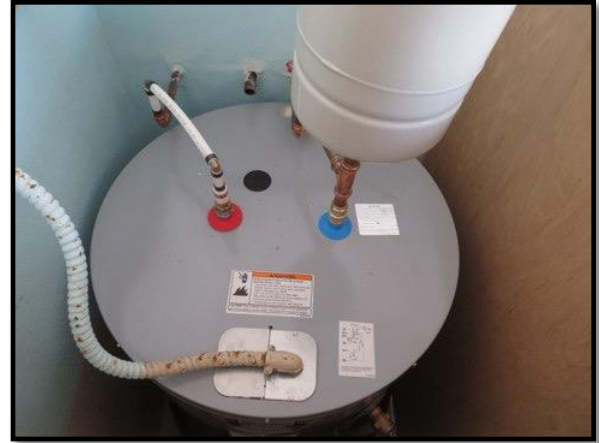
The Association maintains 10 water heaters that serve the laundry rooms. The water heaters are in fair condition at various ages. Residential style water heaters have a useful life of up to 10 years. Sea Coast No. 3 should budget for replacements in 2023 and every 10 years thereafter. The timing will vary.

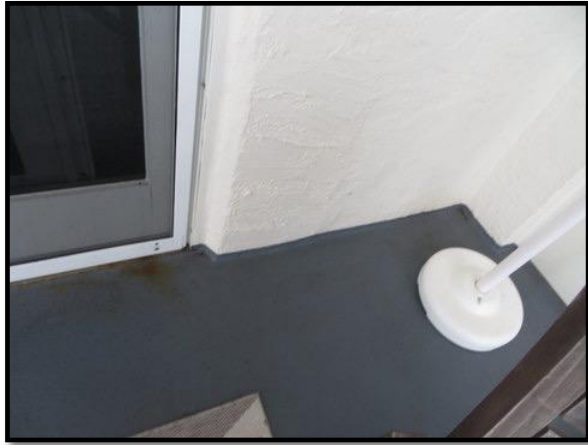
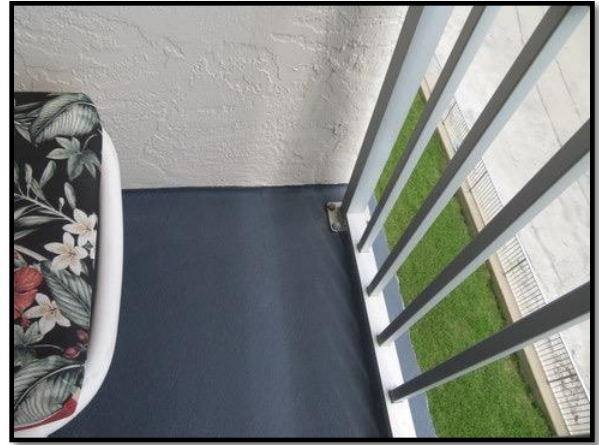
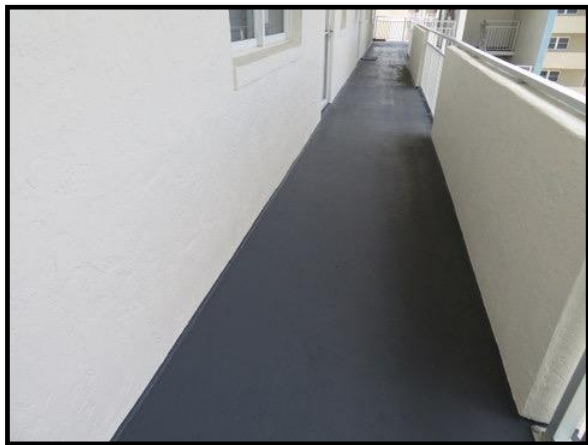
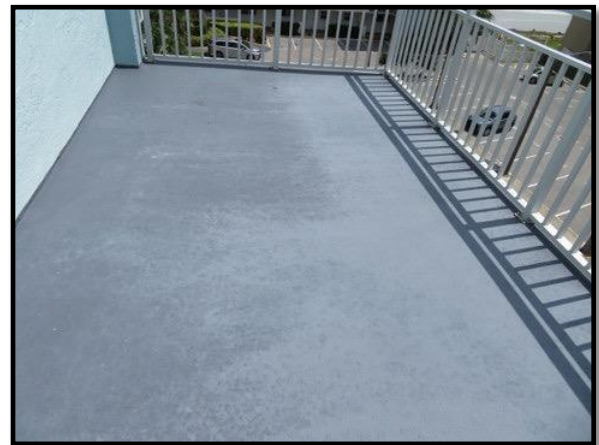
The balconies and breezeways of Sea Coast No. 3 comprise approximately 25,820 square feet of concrete surface. The balconies and breezeways are in good condition overall. The balconies and breezeways utilize a urethane waterproofing system. Balconies and breezeways have a long useful life with the benefit of periodic maintenance. Concrete cracks and spalling occur from the expansion of the reinforcing steel bars due to corrosion. Concrete corrosion is caused by rainwater and chlorides penetrating the surface of the concrete and contacting the embedded steel reinforcement bars. Failure to maintain the balconies can lead to costly repairs.

Figure 1 – Balcony

Figure 2 - Balcony

Figure 3 – Breezeway

Figure 4 - Breezeway

Concrete repairs include replacing compromised reinforcing within associated cracks and spalls. Cracks should be repaired with a gravity feed epoxy. Sea Coast No. 3 should use a hybrid coating consisting of a urethane base coat with a textured acrylic topcoat. The proper way to apply coatings is to remove and reinstall the railings. Waterproof coatings applied to horizontal walking surfaces should meet or exceed the minimum requirements for pedestrian traffic bearing capacity and slip resistance.

The Association should budget for waterproof coatings, cant bead and partial concrete repairs as needed by 2031 and every 10 years thereafter in conjunction with paint finish applications. The cant bead is the seal between the wall and floor surfaces. Sea Coast No. 3 should also budget for removal of the existing coatings by 2031 and every 20 years thereafter.

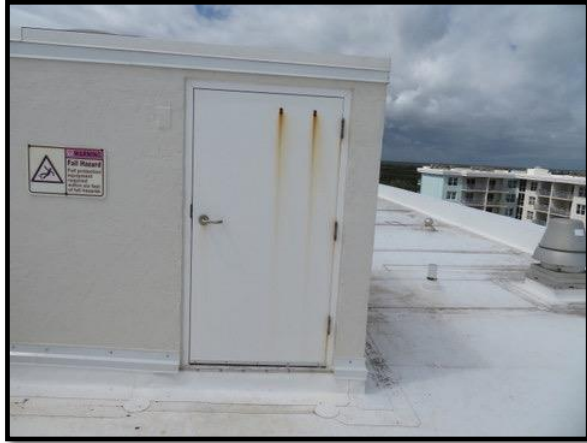
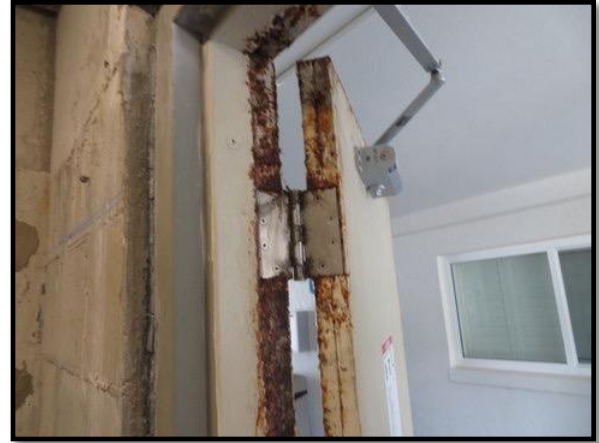
Sea Coast No. 3 maintains 45 common doors. Four of which are fire rated. The common doors are in fair overall condition at various ages. Doors have a useful life of up to 25 years. Based on the varied ages, the Association should budget for replacement of the fire rated doors in 2024 and phased replacement of the remaining doors of up to eight doors every five years beginning by 2028.

Figure 1 – Rooftop Door

Figure 2 – Corroded Door Frame

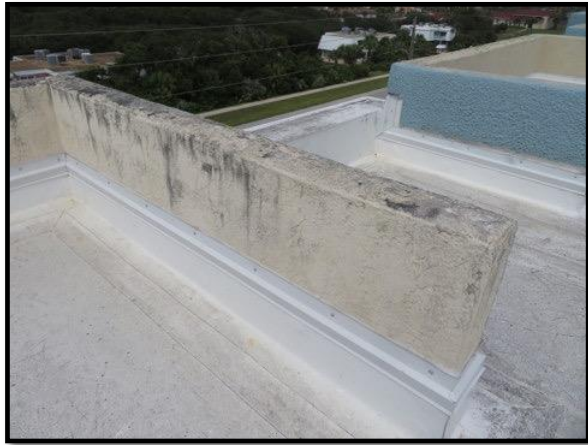
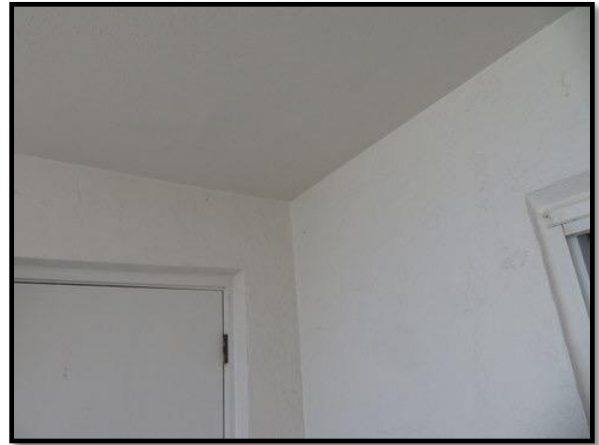
The paint finishes are in fair to good overall condition at an age of two years. Based on recommendations by United Engineering Consultants, Inc., Sea Coast No. 3 should budget for the beachside paint finishes every five years and the remaining paint finishes have a useful life of up to 10 years. In addition, phased paint removal applications are included beginning by 2031 and concluding by 2041. Dry film thickness (DFT) above 20 mils can be problematic.

Figure 1 – Rooftop Parapet Wall

Figure 2 – Balcony Paint

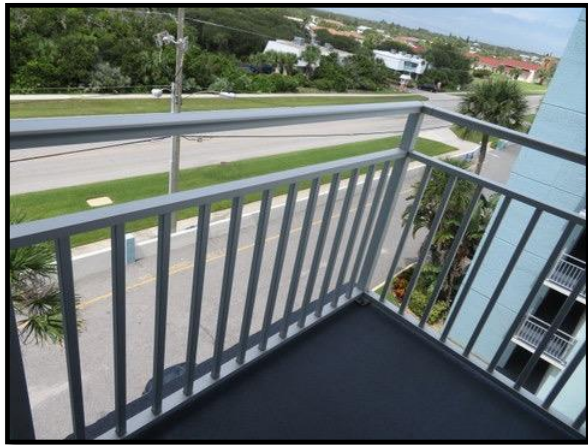
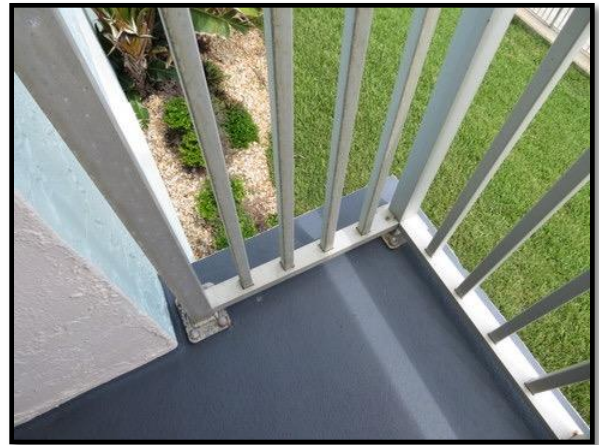
The Association maintains 3,840 linear feet of aluminum railings. The railings are in fair overall condition at an age of 12 years. The finish on aluminum fences is relatively maintenance free. While aluminum doesn't rust, it does corrode over time. Aluminum railings have a useful life of up to 35 years. The major concern with railings is safety. Sea Coast No. 3 can maximize the useful life by repairing connections and fasteners promptly when and if they fail. These activities should be funded through the operating budget on an as needed basis. The Association should budget for railing replacements by 2031 in conjunction with the next restoration project. Sea Coast No. 3 should make sure stainless-steel fasteners are used.

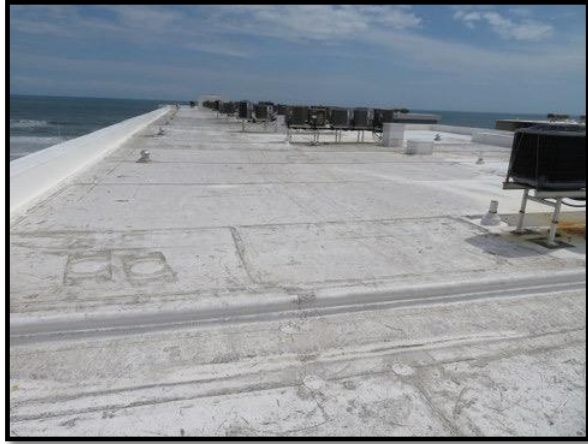
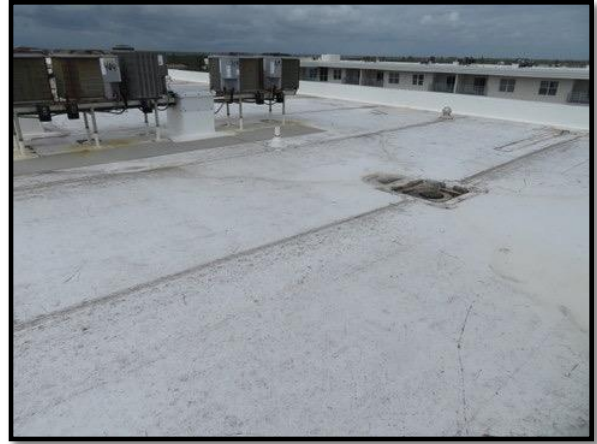
The Association maintains 262 squares of flat roof. The flat roof is in good condition at an age of three years. Flat roof coverings have a useful life from 15- to 20-years.

There are several different options for flat roofs. The estimate of cost is based on a TPO roofing system. TPO can be mechanically attached, fully adhered, self-adhered, ballasted, or induction welded. The advantages of TPO are strong heat welded seams and a highly reflective surface saving on energy costs. The Association should budget for replacement of the flat roof system by 2040. Interim annual inspections are recommended funded through the operating budget. It is assumed that the roof was not overlaid and the estimate of cost is based on tearing off one roof only.

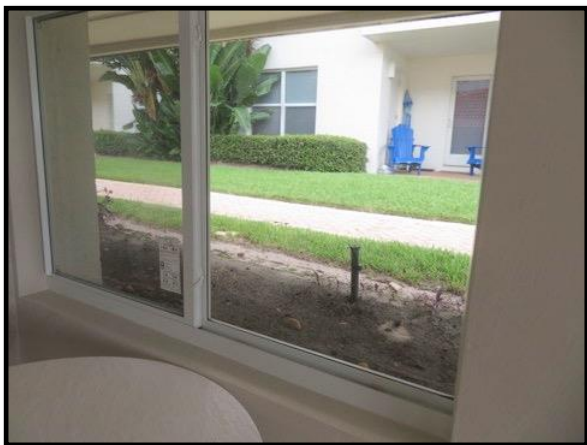
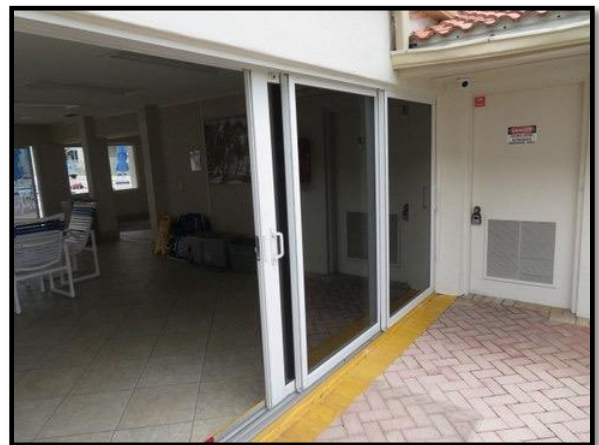
The windows and glass doors of the clubhouse comprise 800 square feet. The windows and glass doors are original and in fair overall condition. Windows and glass doors of this type have a useful life of up to 45 years.

Figure 1 – Window

Figure 2 - Door

The need to replace windows can be due to various reasons such as consistency in style and condition. There will be a cost savings with coordinated replacement. The Association should budget for replacement of the windows and doors by 2028.

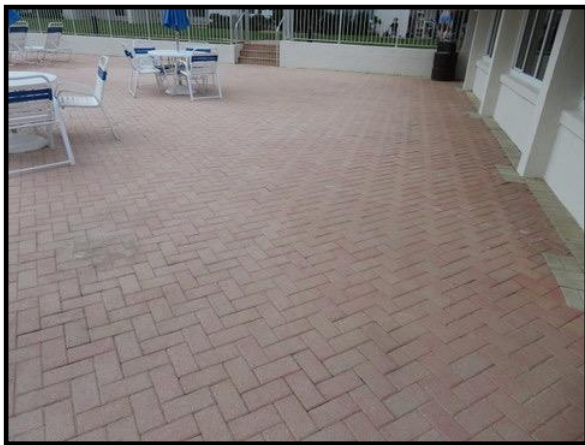
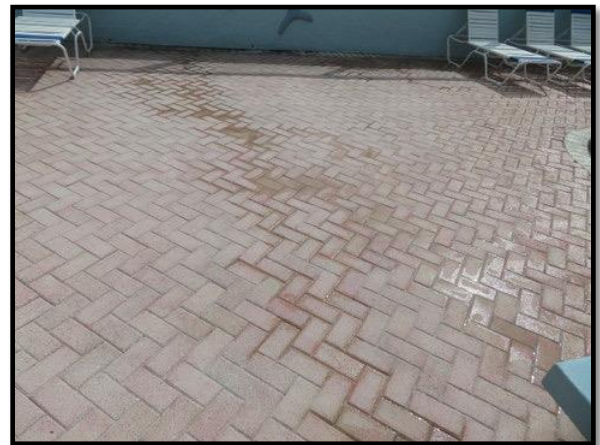
The pool deck comprises approximately 15,390 square feet of pavers. The quantity includes the sidewalks. The pavers are in fair overall condition at an age of 20 years. Pool deck pavers have a useful life from 20- to 30-years with the benefit of periodic maintenance.

Periodic maintenance includes pressure washing, resetting as needed and an application of sand between the pavers followed by a sealer application every three years. The Association should budget for this maintenance activity beginning in 2029. The sealer quantity includes the new paver deck. The need to eventually replace the pavers may be desired based on aesthetics. The Association should budget for replacement of the pavers by 2026. Interim repairs should be funded through the operating budget as needed.

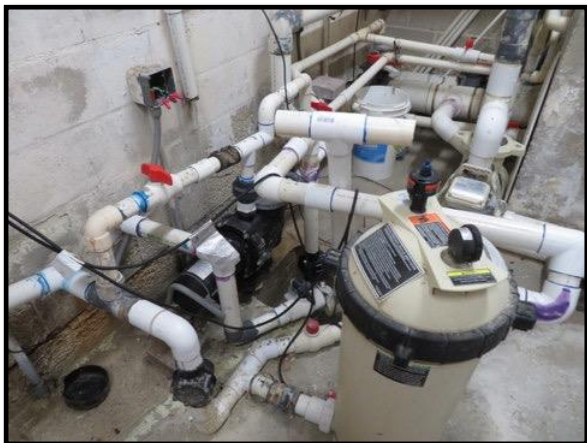
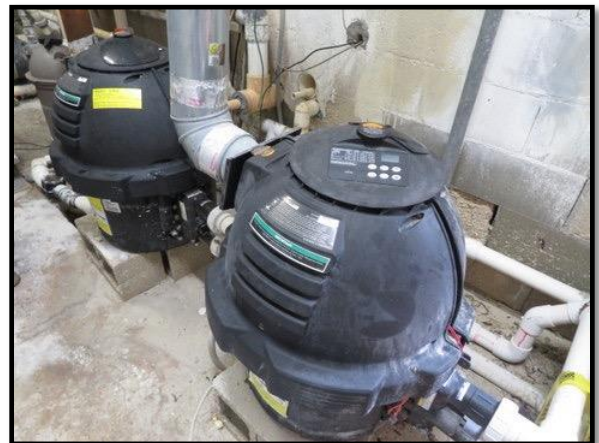
The mechanical equipment includes two heaters, pumps, filters and chlorinators. The mechanical equipment is in fair overall condition at various ages.

The pool equipment has a useful life from 5- to 10-years with the benefit of ongoing maintenance. This ongoing maintenance includes partial replacements of the pumps, filters and chlorinators as needed. The Association should fund these minor partial replacements through the operating budget. The Association should budget for phased replacements beginning by 2026 and concluding by 2027 prior to the pool finishes. Subsequent phased replacements are likely every five years thereafter.

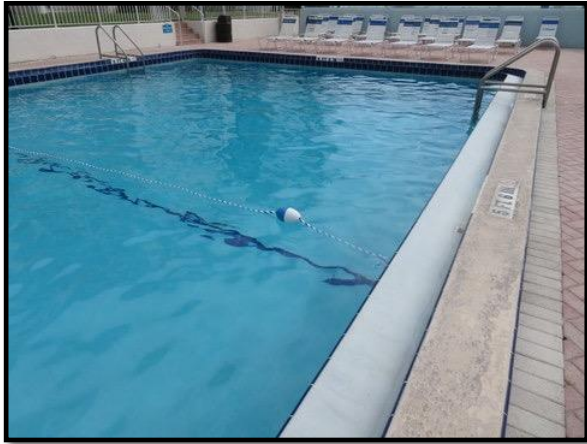
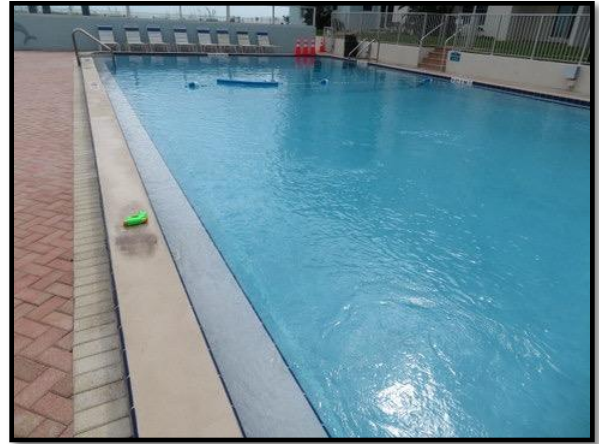
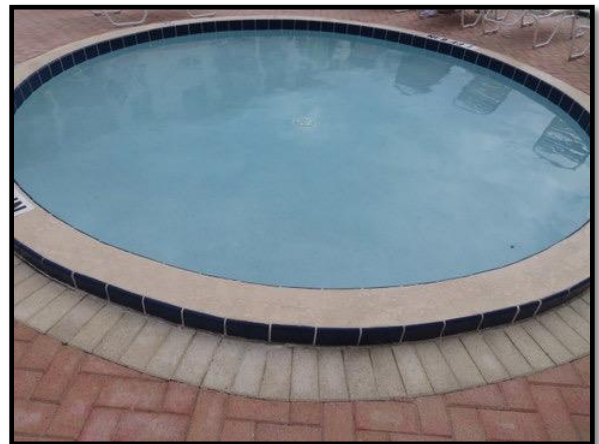
The finishes at the pool walls and floors surfaces are in fair overall condition at an age of five years. Pool finishes have an anticipated useful life from 10- to 15-years.

Figure 1 – North Pool

Figure 2 – South Pool

The Association should budget for resurfacing of the wall and floor areas, as well as replacement of the pool waterline tile, by 2028 and every 10 years thereafter. Typically, minor upgrades will be needed to bring the pool up to current code. Potential repairs to the underlying pool structure may raise the estimate of cost.

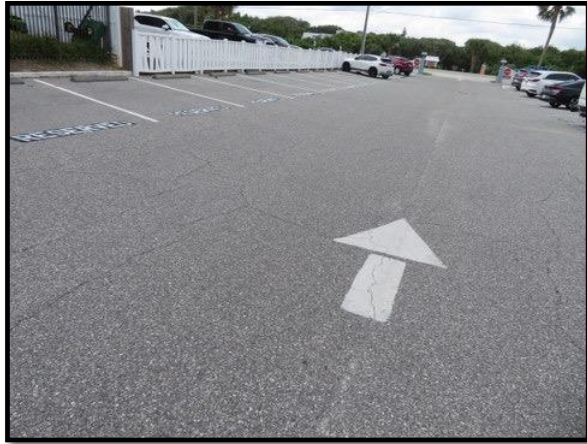
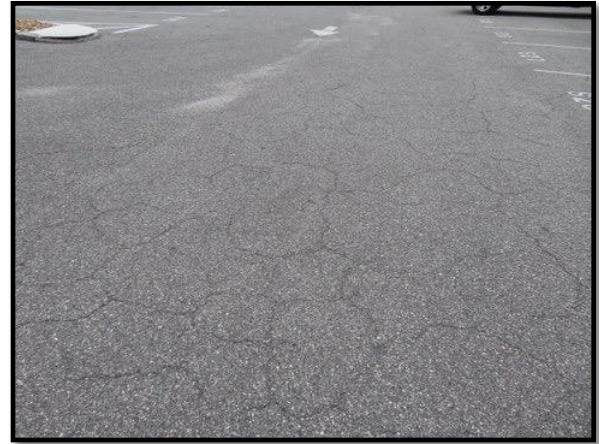
The Association maintains approximately 4,555 square yards of asphalt streets and parking areas. The asphalt pavement is in fair overall condition at an age of 10 years. Asphalt pavement comprises multiple layers. Typically the top layer or surface course deteriorates over time and can be milled or removed and overlaid or replaced. The following diagram depicts typical pavement layers.

A combination of area patching, crack repair and milling should occur before the overlayment. Areas that exhibit potholes, alligator cracks and areas of pavement that are deteriorated from vehicle fluids should all be repaired prior to overlayment. Area patching may require total replacement of isolated areas of pavement. The base course for residential subdivision roadways designed for light traffic is often six inches thick. The paving contractor should seal all cracks. Crack repair minimizes the chance of underlying cracks coming through the overlayment.

The useful life of the asphalt pavement surface course varies from 15- to 25-years due to design, quality of construction, materials and maintenance. The Association should budget for a mill and overlay of the pavement by 2032. The Association should retain an engineer for quality control.

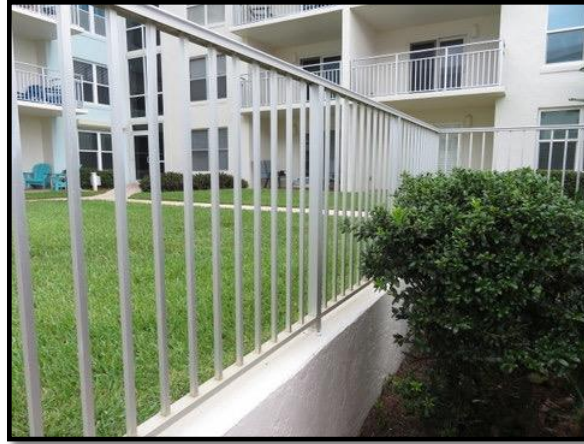
The Association maintains 430 linear feet of railings that surround the pool area and 550 linear feet of aluminum railings located atop the sea wall. The pool area railings are in fair overall condition at an age of 17 years. The Association should budget for the pool railing replacements by 2041. Management and the Board report that the Association plans to replace the sea wall railings due to storm damage in the near term funded through a special assessment. The Association should fund for partial replacement of up to eighty percent (80%) of the sea wall railings by 2053.

Figure 1 – Pool Area Railing

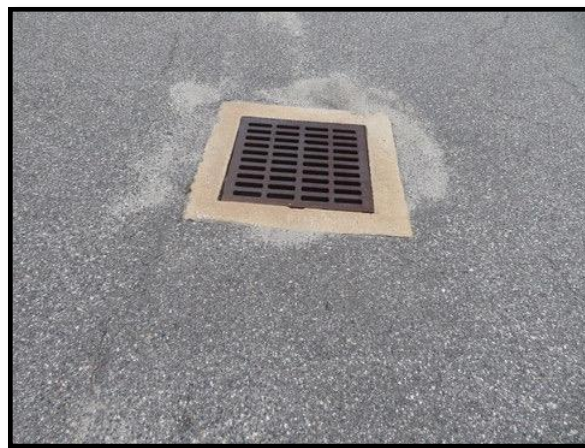
The overall reported condition of the stormwater structures is good. Stormwater systems have a long useful life with the benefit of ongoing maintenance. Achieving this useful life typically requires interim capital repairs or partial replacements. Maintenance of stormwater systems is required in every municipality as a condition for use of the land to prevent adverse impacts on adjoining properties. The Association should routinely keep the stormwater system clear every three- to four-years beginning in 2026.

Figure 1 – Catch Basin
