**Sea Coast Management No. 2., Inc.**

# **RESERVE STUDY UPDATE REPORT**

**For 30-Year Projection Period Beginning January 1, 2018**

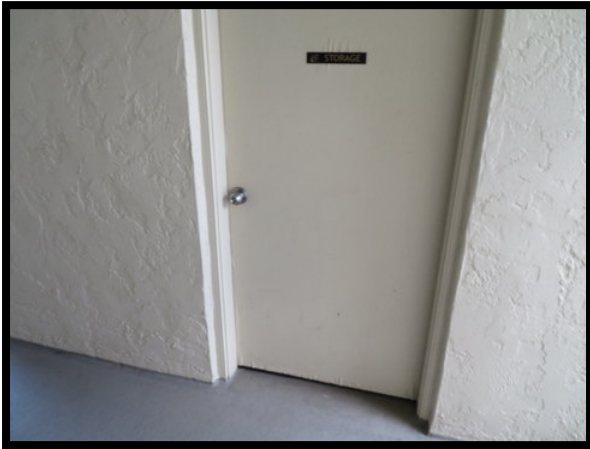
**Doors, Common** – Management reports that the Association repaired some common doors since the last Reserve Study. Therefore, a timing adjustment from 2016 to 2019 is included in this Reserve Study Update.

Figure 1 Common Door

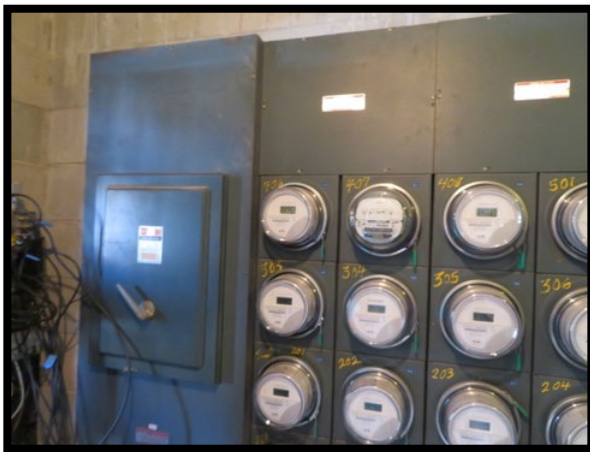
**Electrical Systems** – The Association maintains common electrical systems. Electrical systems have a long useful life of up to 75 years and beyond. However, periodic repairs and partial replacements are likely as the system ages. The Association should budget for this activity by 2026 and every 10 years thereafter in conjunction with the life safety system and elevator equipment. The estimates of costs are noted on Line Item 1 of Appendix A.

Figure 2 Electrical Systems

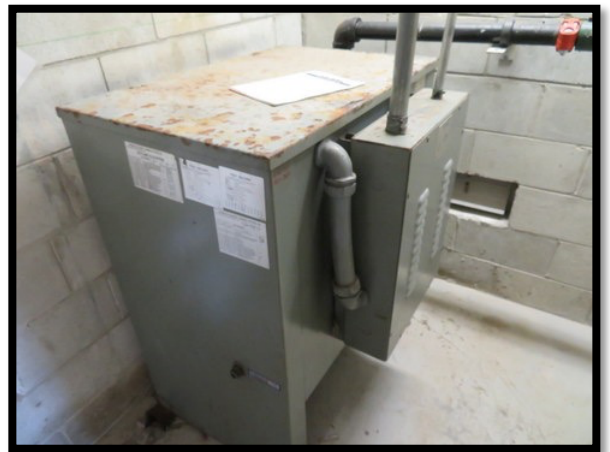
**Elevators, Cylinders and Pumps** – The previous Reserve Study excluded the elevator cylinders and pumps because they estimated replacement year fell beyond the 30 year analysis. The two elevator cylinders and pumps are in good reported condition overall at approximate ages of five years. The elevator cylinders and pumps have a useful life of up to 35 years. Sea Coast No. 2 should budget for replacements by 2046. The estimates of costs are noted on Line Item 3 of Appendix A.

Figure 5 Elevator Mechanical Equipment

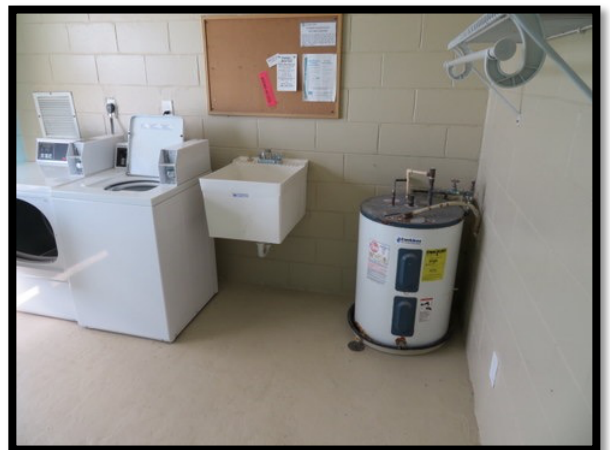
**Laundry Equipment** – The Association took over responsibility of the laundry machines since the last Reserve Study. The laundry machines are in good condition at an age of less than one year. The laundry machines have a useful life from 5- to 10-years. Sea Coast No. 2 should budget for replacements by 2025 and every seven years thereafter. The estimates of costs are noted on Line Item 5 of Appendix A.

Figure 6 Laundry Equipment

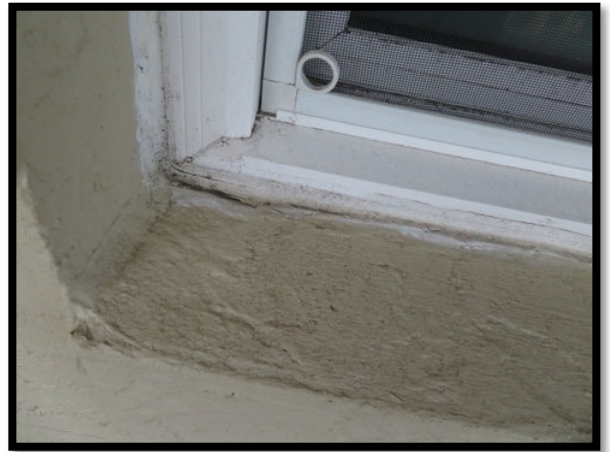
Figure 11 Deteriorated Window Sealant

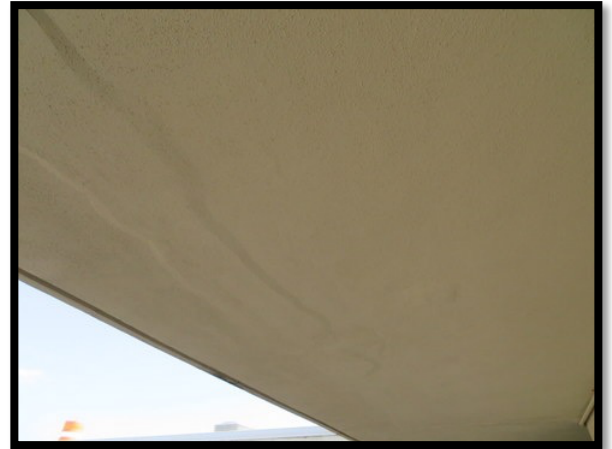
**Restoration Project** – Management and the Board report that the top floor is experiencing significant spalling. Page 3 of Appendix B depicts this condition in Figures 15 and 16. Sea Coast No. 2 should budget for a near term restoration project in 2018. The estimate of cost will vary.

Figure 16 Top Breezeway Ceiling Bubbling

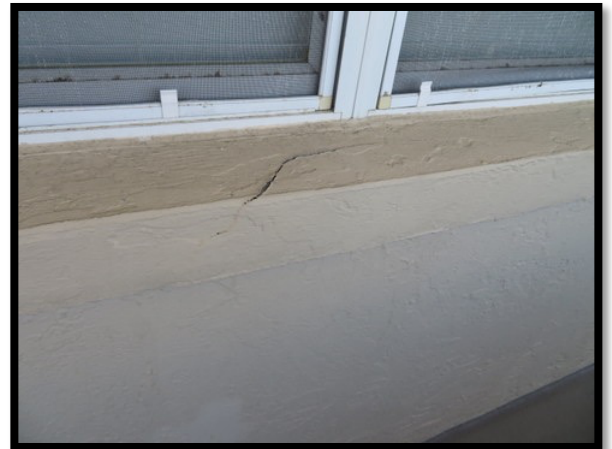
Figure 17 Window Sill Crack

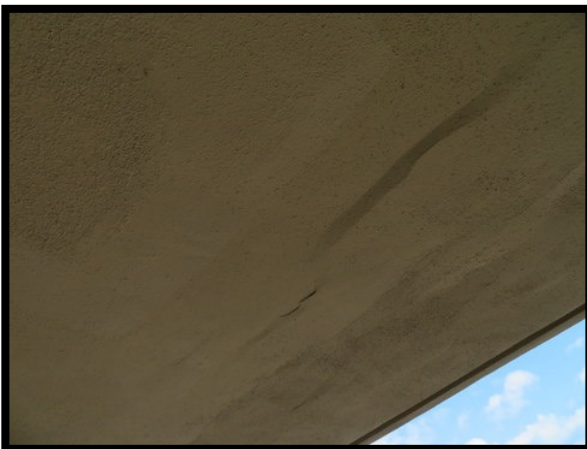
Figure 15 Top Breezeway Ceiling Bubbling

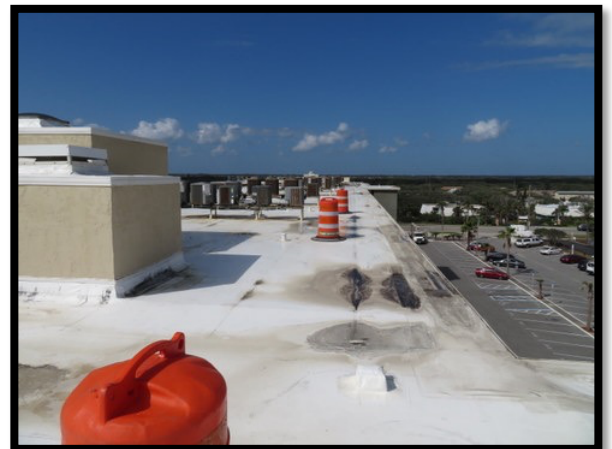
**Roof, Flat (Resident Building)** – Management and the Board report that the Association plans to replace the roof in 2018 due to hurricane damage back in 2017. The current replacement project is covered through insurance. A subsequent replacement is likely by 2038.

Figure 18 Flat Roof Overview

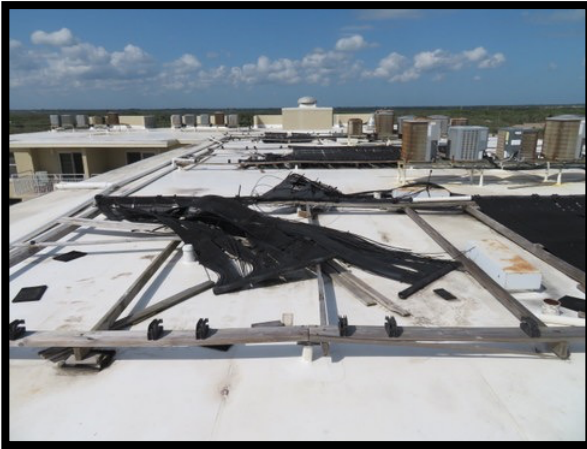
**Solar Panels** – Management and the Board report that the Association plans to replace the solar panels in 2018 due to hurricane damage back in 2017. The current replacement project is covered through insurance. A subsequent replacement is likely by 2038.

Figure 19 Solar Panels

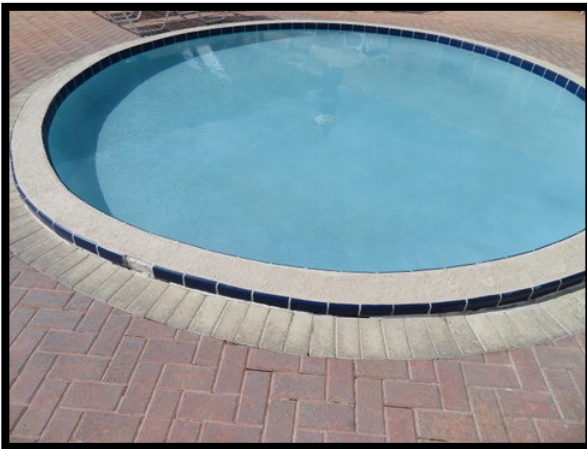
Figure 33 North Spa

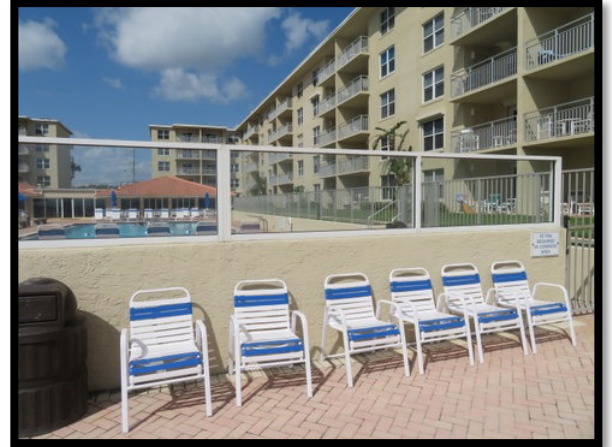
**Wind Screen, Glass** – The last Reserve Study had replacement of the pool wind screen beyond the 30 year analysis. The wind screen is in good condition at an age of 12 years. Glass wind screens have a useful life of up to 40 years. Sea Coast No. 2 should budget for replacement of the wind screen by 2046. The estimates of costs are noted on Line Item 32 of Appendix A.

Figure 34 Glass Wind Screen

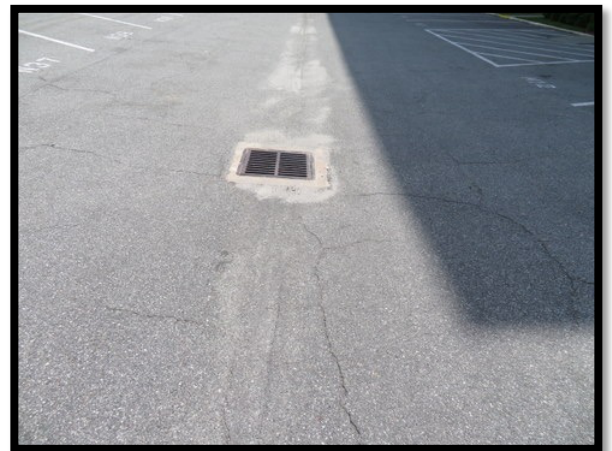
**Storm Water System** – The Board reports that the Association has been having issues with the storm water system since the last Reserve Study. The previous Reserve Study included partial storm water system repairs in conjunction with repaving. Sea Coast No. 2 should also budget for near term repairs in 2019. The estimate of cost will vary.

Figure 42 Storm Water Catch Basin
