Revised
FULL RESERVE STUDY

**Sea Coast
Management No. 2, Inc.**

New Smyrna Beach, Florida
Inspected - July 23, 2021
Revised - December 13, 2021

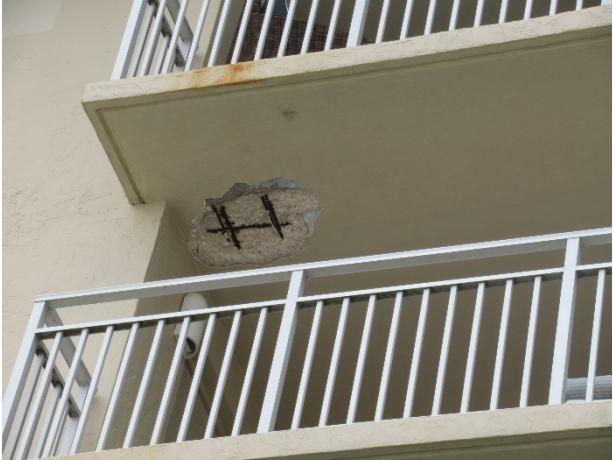
Condition: The balconies and breezeways are currently undergoing repairs, waterproof coating applications and paint finish applications with some areas yet to be repaired. We note significant spall at one balcony at the east side of the building and various cracks and rust stains at the balconies and breezeways that are yet to be repaired. Management informs us that the east and south-east face of the building, where the balconies are located, receive more ocean spray and require more extensive concrete repairs than the other areas of the building where the breezeways are located.

Balcony with significant spall and exposed reinforcing steel

Useful Life: Capital repairs including a close-up visual inspection, patching of delaminated concrete, routing and filling of cracked concrete, and waterproof coating applications every 8- to 12-years.

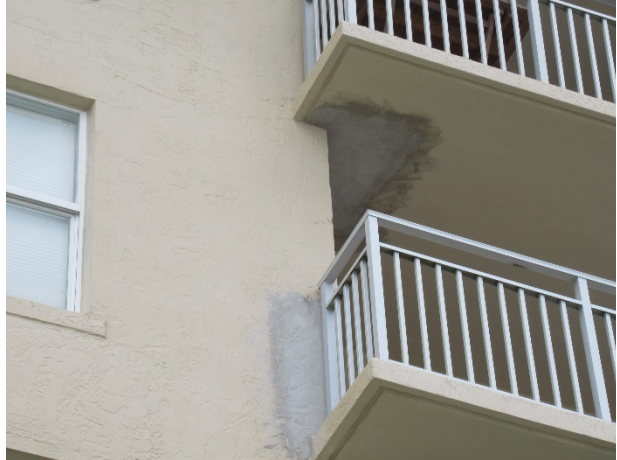
Balcony with recently repaired concrete

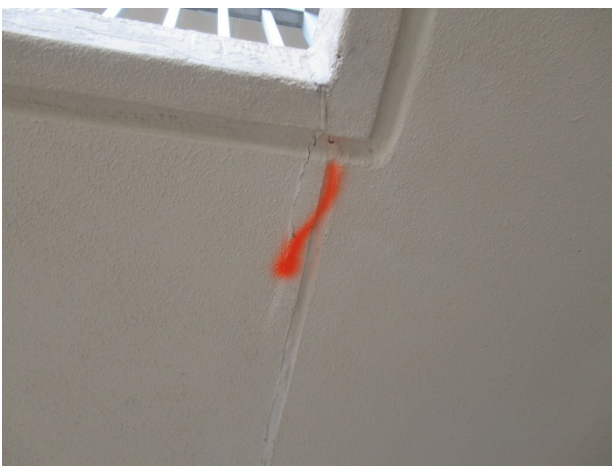
Crack to breezeway underside to be repaired

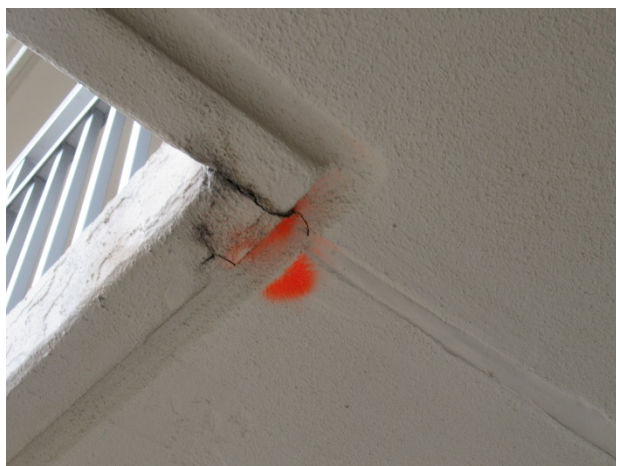
Crack to breezeway underside to be repaired

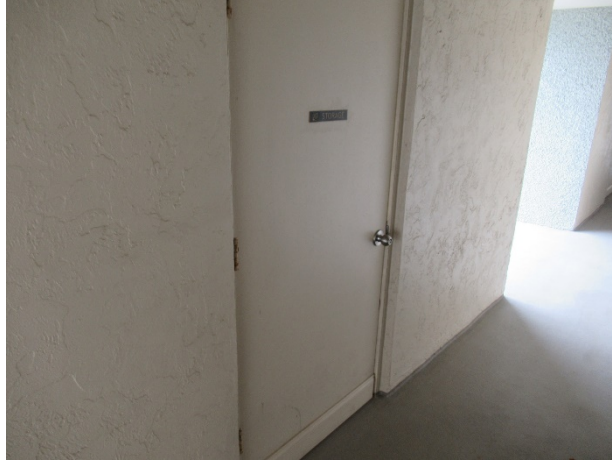
Condition: Fair overall with minor areas of rust formation at some doors.

Typical storage room door

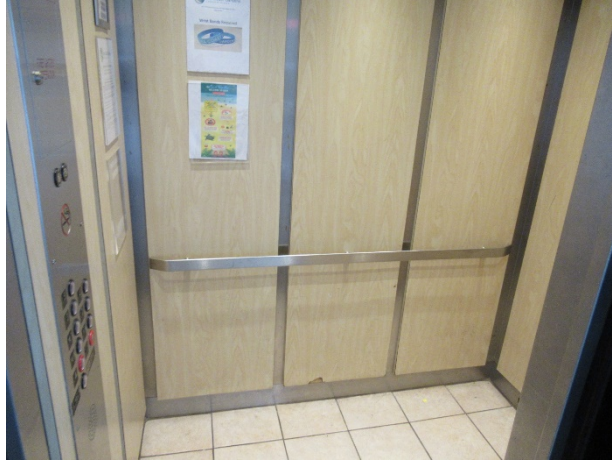
Condition: Fair overall with delaminated wall coverings and damage to the finishes. Management informs us that the Association plans to replace the elevator finishes in the near-term.

Elevator finishes

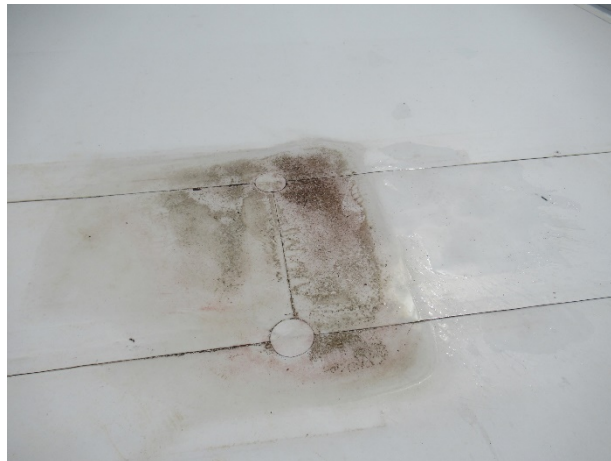
Condition: Good overall with minor areas of stains and ponding water.

Stains and ponding water

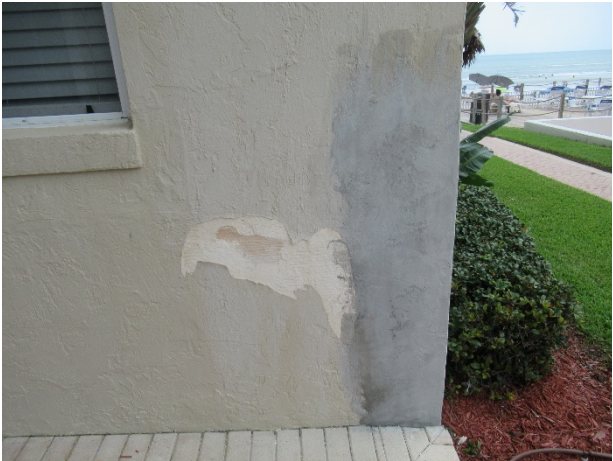
Stucco not yet repaired

Useful Life: We recommend inspections, repairs and paint finish applications every 8- to 10-years.

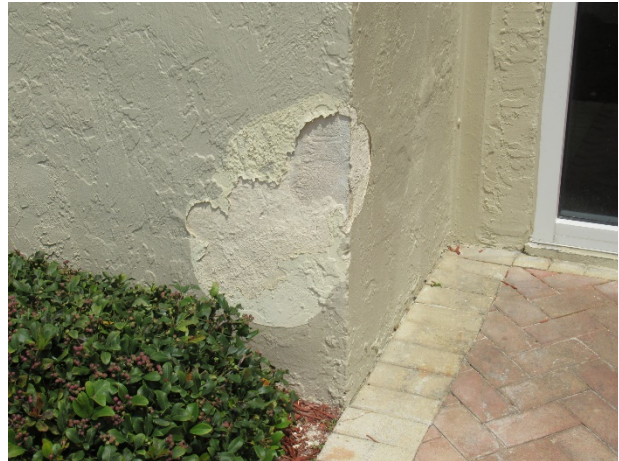
Stucco not yet repaired

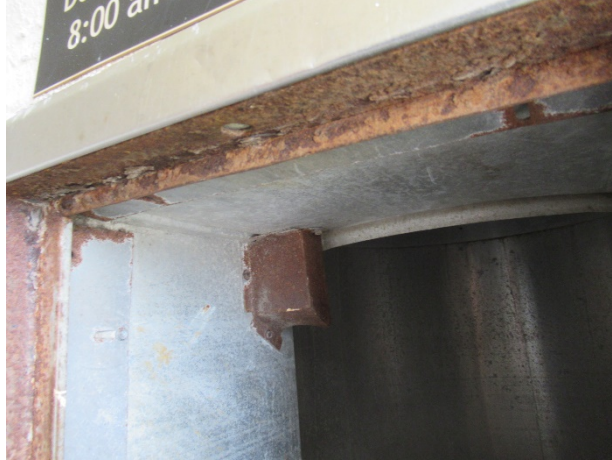
Condition: The chutes are in fair condition based on the visible sections with the exception of the doors, which are in fair to poor condition with rust.

Rust at door and collar to be replaced

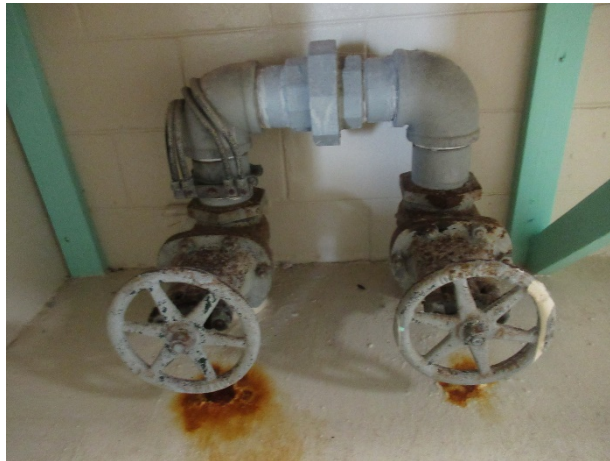
Condition: Reported satisfactory. We note evidence of rust and corrosion to the valves.

Large diameter valves

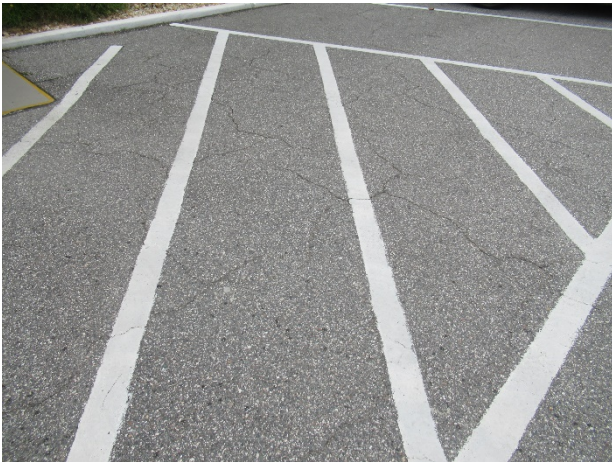
Condition: Fair overall with block cracks

Asphalt pavement with block cracks

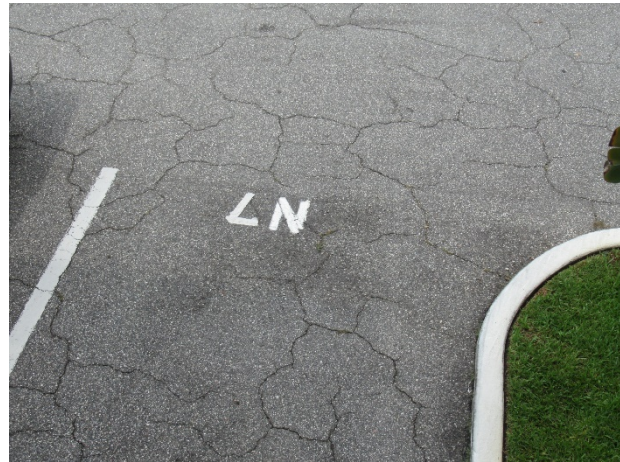
Asphalt pavement with block cracks

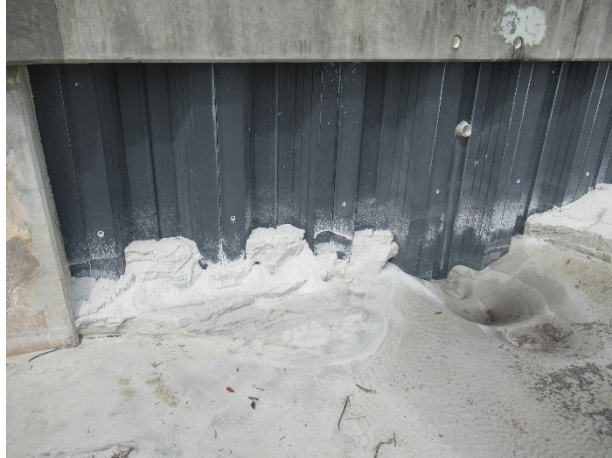
Conditions: The bulkheads are in good to fair condition based on our non-invasive inspection, with no significant deterioration visually evident. We note one area of wash-out at the base of the wall near a drain.

Vinyl bulkhead with wash-out near drain

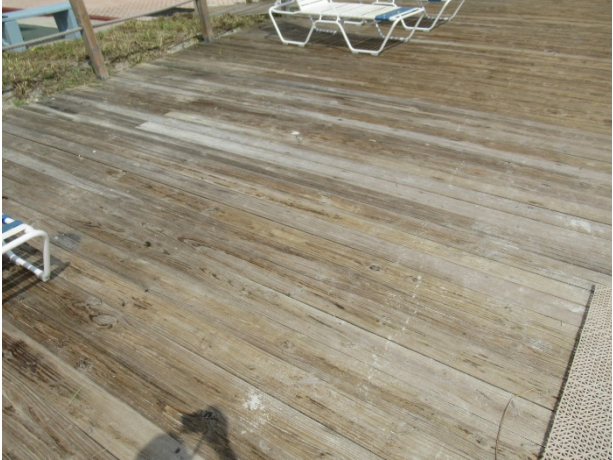
Condition: Fair overall condition with weathered deck boards

Weathered deck boards

Useful Life: Total replacement every 20- to 30-years with proper maintenance and interim replacement of the deck boards every 10- to 15-years. The rates and types of deterioration are not uniform due to the nature of wood. Replacement is normally an ongoing process which eventually leads to a complete replacement for economic or aesthetic reasons.

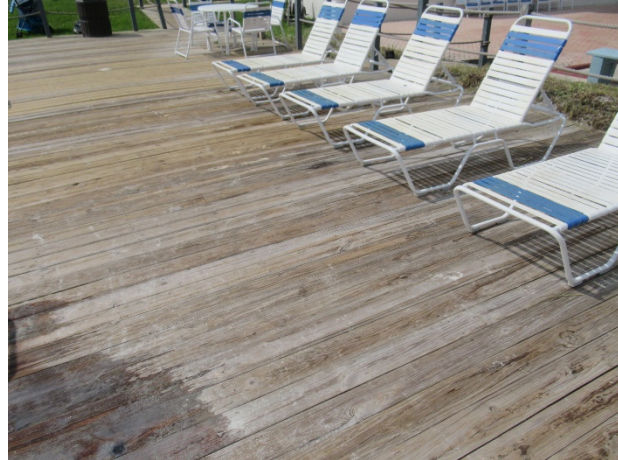
Weathered deck boards

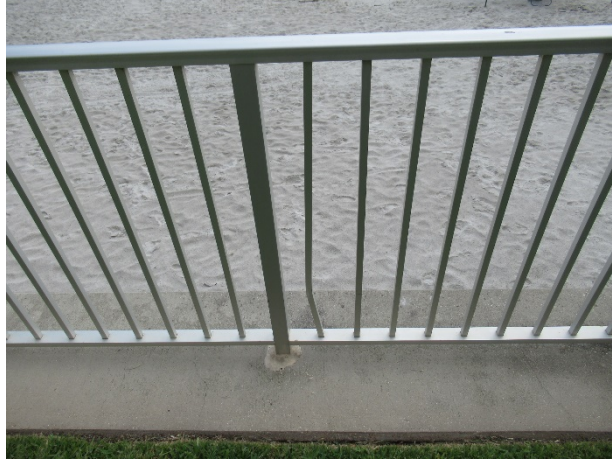
Condition: Good to fair overall with isolated bent pickets

Bent picket

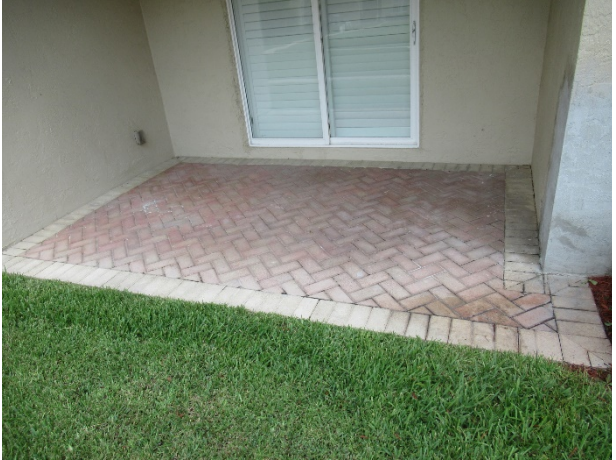
Condition: Fair overall with color fade and areas of settlement evident

Typical paver patio

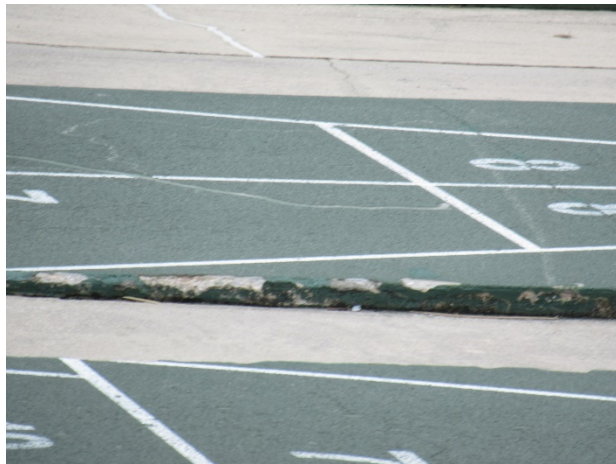
Condition: Fair overall with areas of deterioration

Deterioration to shuffleboard courts

Useful Life: Repairs and color coat applications every Four- to six-years

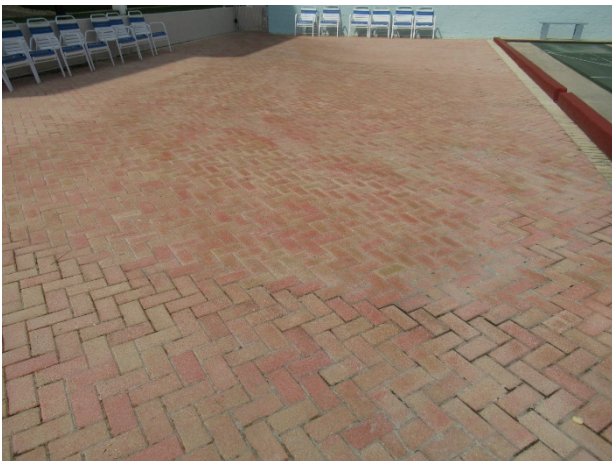
Condition: Unsatisfactory. Management informs us that the Association intends to replace the pavers in approximately 2026 and will apply a sealer to the pavers in approximately 2023.

Pool deck pavers

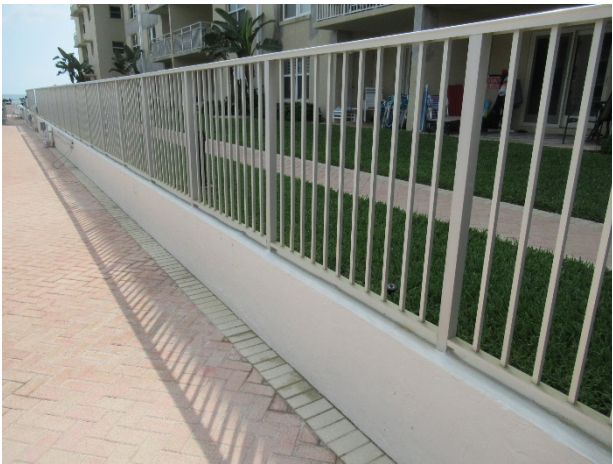
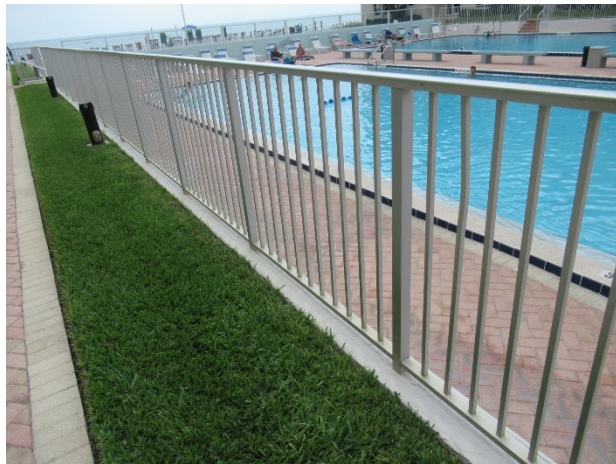
Condition: Good to fair overall condition with areas of bent pickets

Pool fence overview
