Office: (888) 927-7865
Fax: (813) 200-8448
Contact@customreserves.com
5470 E Busch Blvd., Unit 171
Tampa, FL 33617

Sea Coast Management No. 2, Inc.

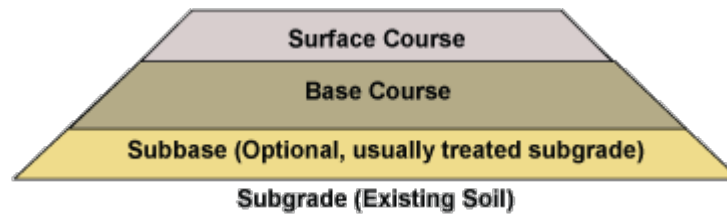
A mill and overlay is a method of repaving of the surface course where cracked, worn and failed pavement is mechanically removed or milled. A new layer of asphalt is overlaid atop the remaining sound pavement. Milled pavement removes part of the existing pavement and permits the overlay to match the elevation of areas such as adjacent catch basins, curbs and gutters. The milled pavement should be properly bonded to the new overlayment. Overlayment thicknesses range from one to two inches. Variable thicknesses are often necessary for proper drainage.

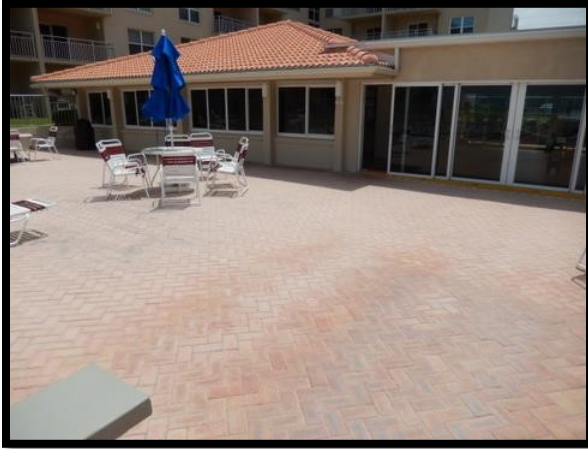
Figure 2 Clubhouse Exterior

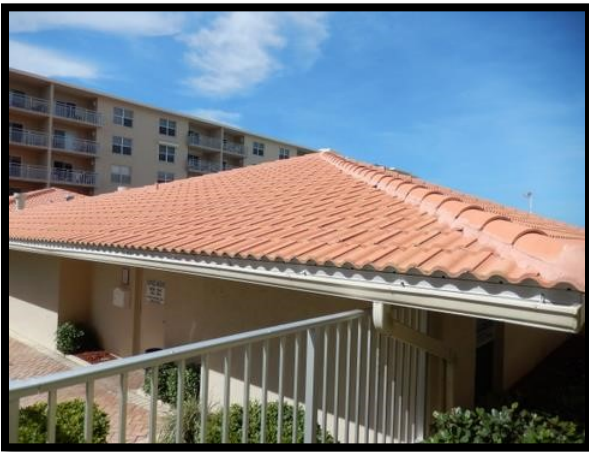
Figure 9 Roof Drip Edge Rust

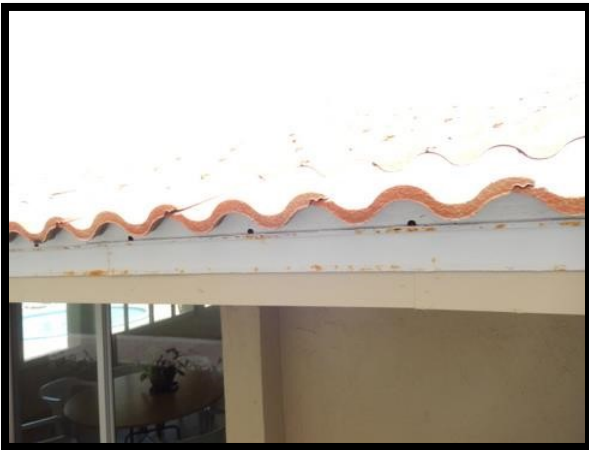
Figure 10 Split System Condensing Unit

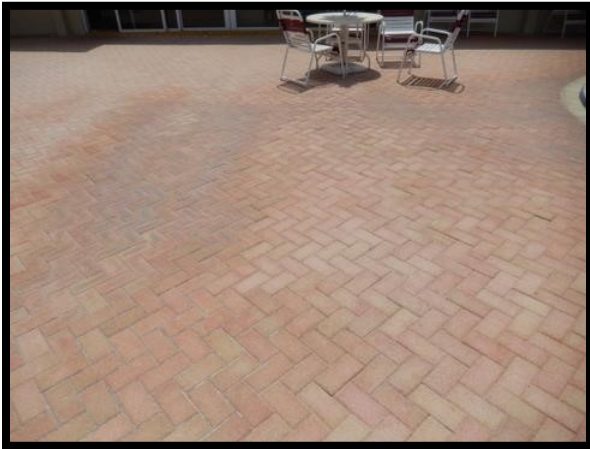
Figure 14 Pool Deck Wear

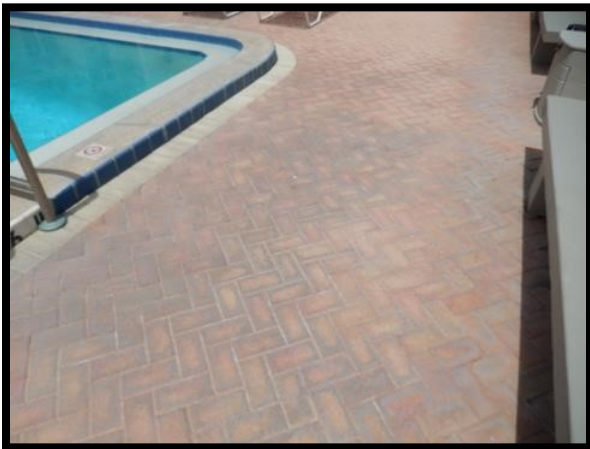
Figure 15 Pool Mechanical Equipment

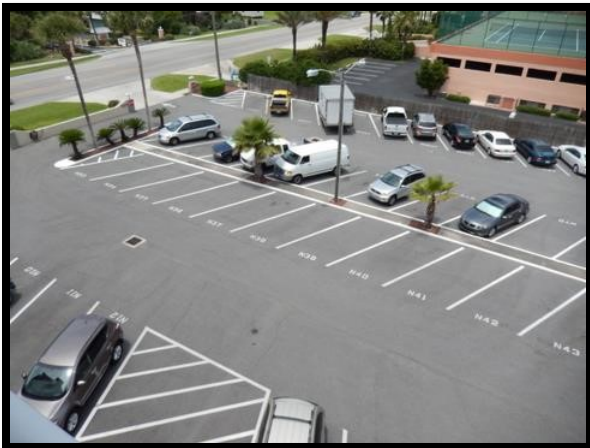
Figure 22 Asphalt Cracks

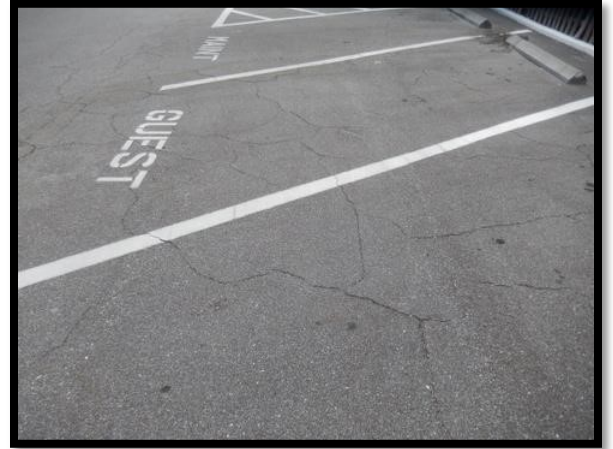
Figure 23 Bollard Light

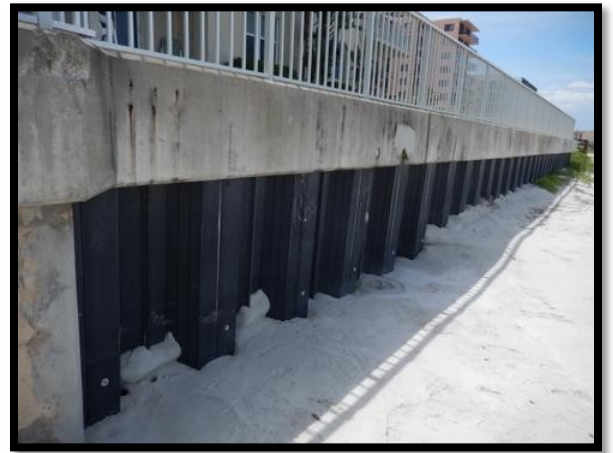
Figure 27 Light Pole – Note Fixture Rust

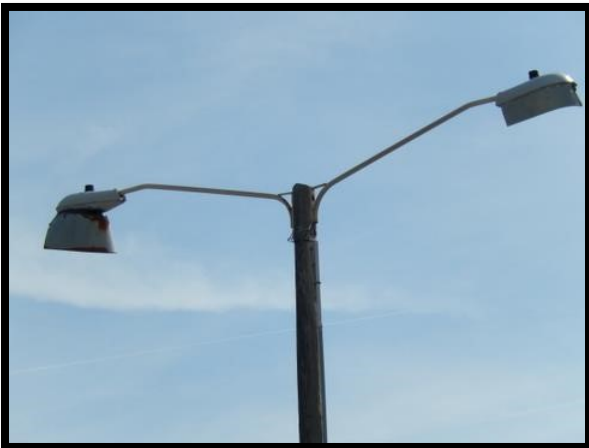
Figure 30 Concrete Sea Wall Cap Cracks

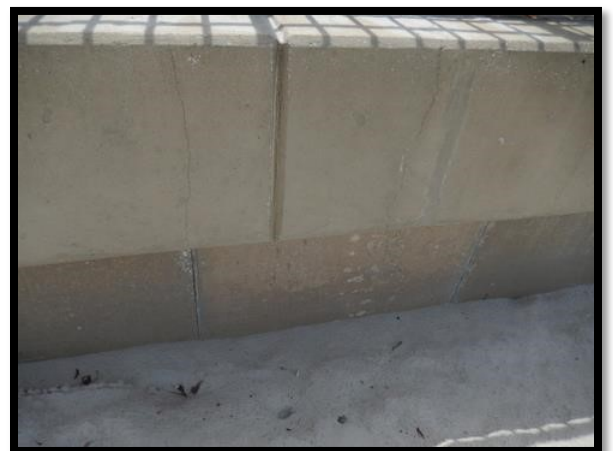
Figure 31 Sea Wall Drainage Pipes

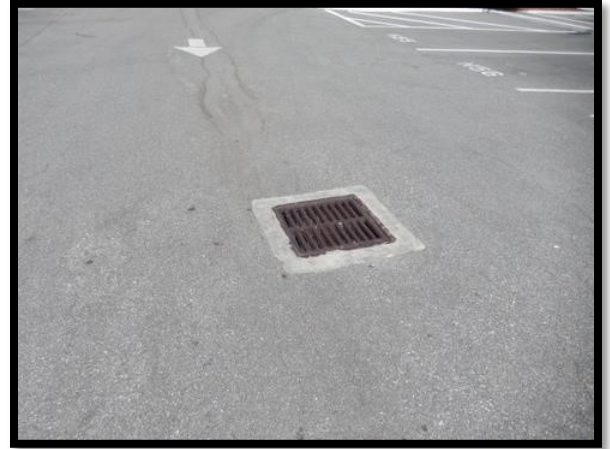
Figure 32 Sea Wall Cap Deterioration

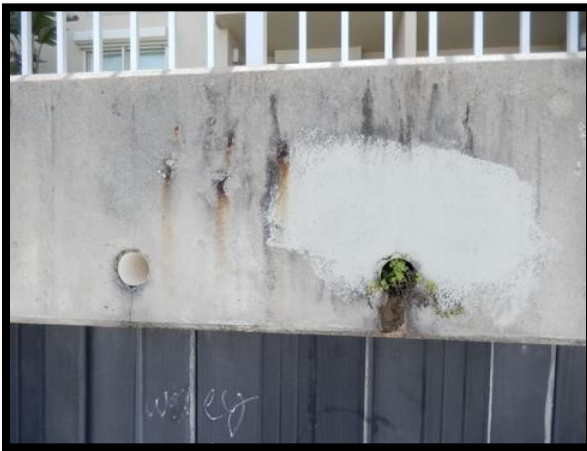
Figure 35 Storm Water Catch Basin

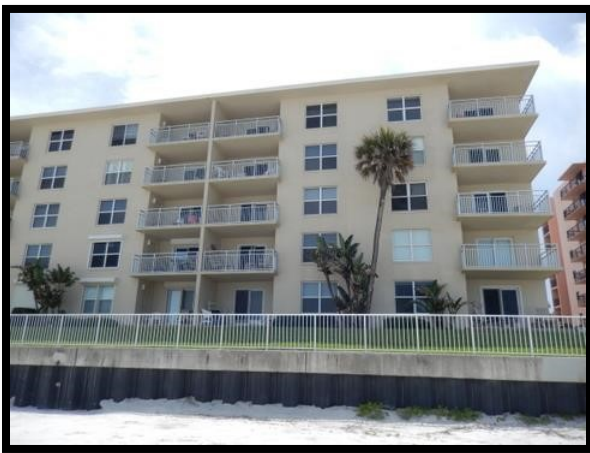
Figure 42 Common Door Deterioration

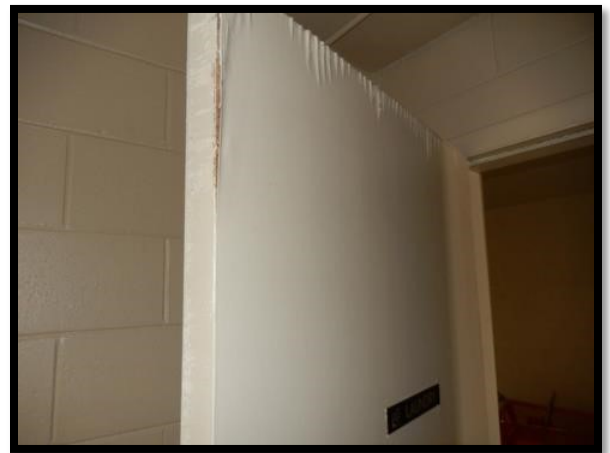
Figure 43 Elevator Cab Finishes

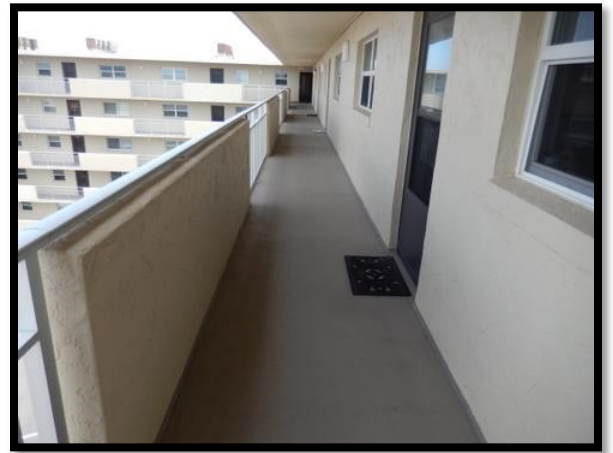
Figure 54 Stucco Cracks

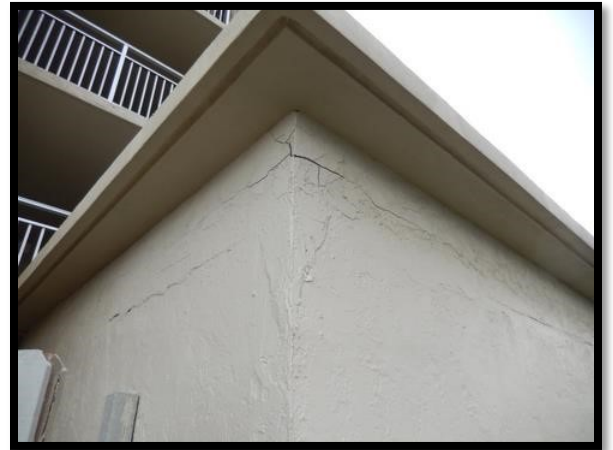
Figure 55 Patio Pavers

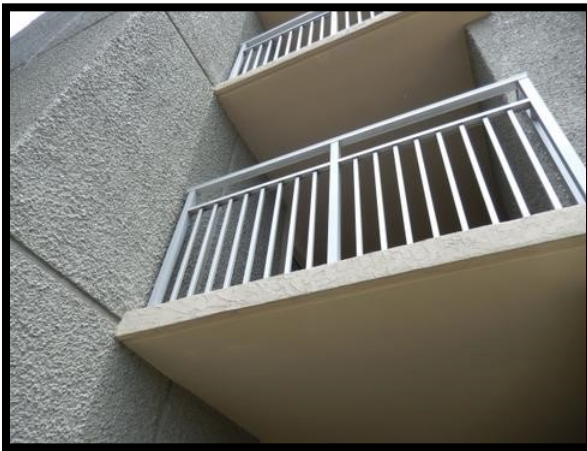
Figure 57 Roof Pipe Penetration - Note Rust

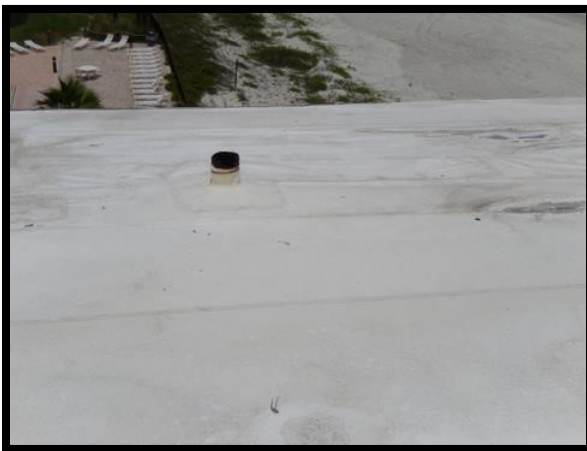
Figure 58 Roof Overview

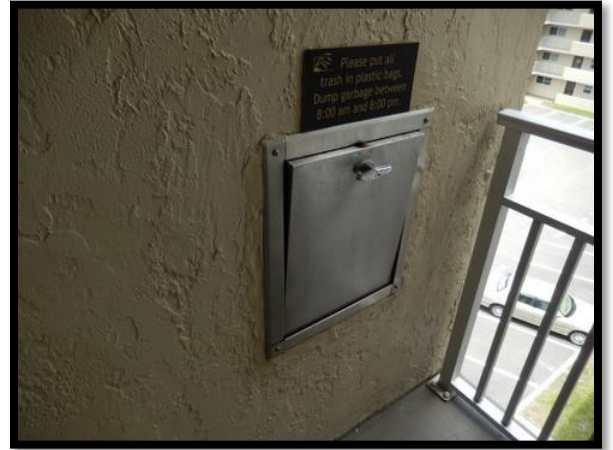
Figure 62 Trash Chute - Note Rust

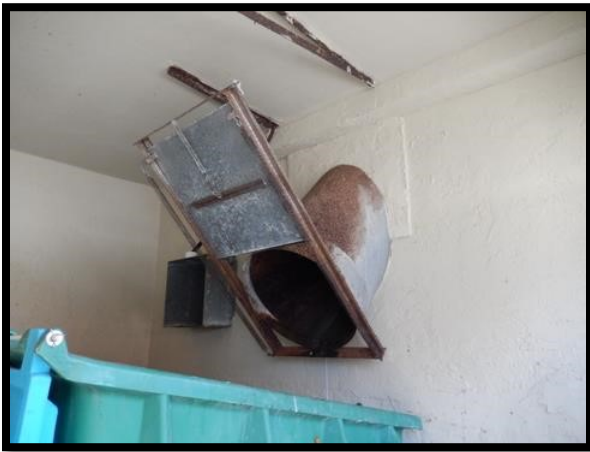
Figure 64 Common Windows and Door

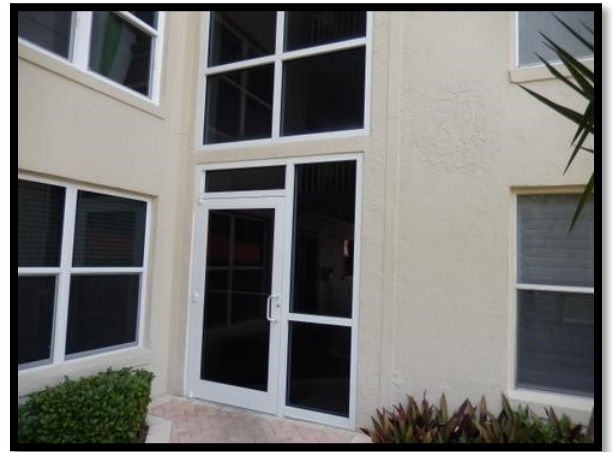
EXPENSE CHART AND COMPARISON GRAPH

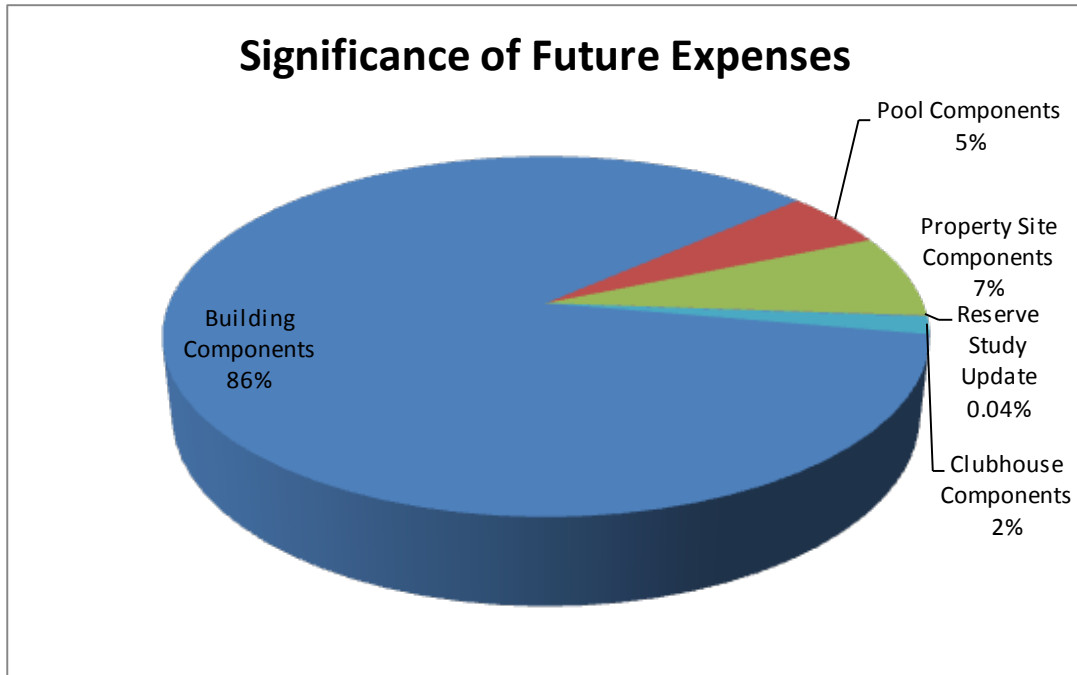
The following graph depicts the next 30 years of Projected Expenses, Reserve Balances and cash flow Recommended Contributions:
