**SEA COAST  
MANAGEMENT NO. 2., INC.  
STRUCTURAL INTEGRITY RESERVE  
STUDY**

**For 30-Year Projection Period: FY 2023 through FY 2053**

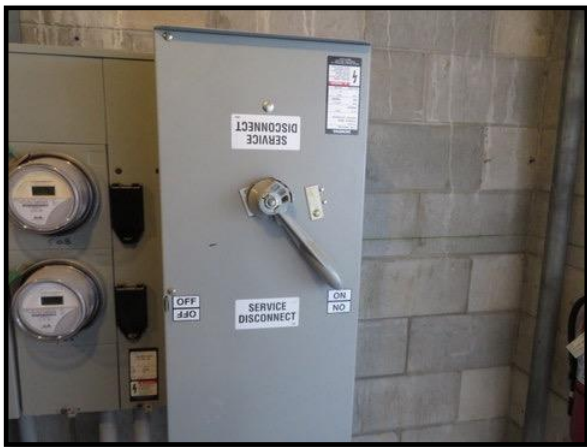
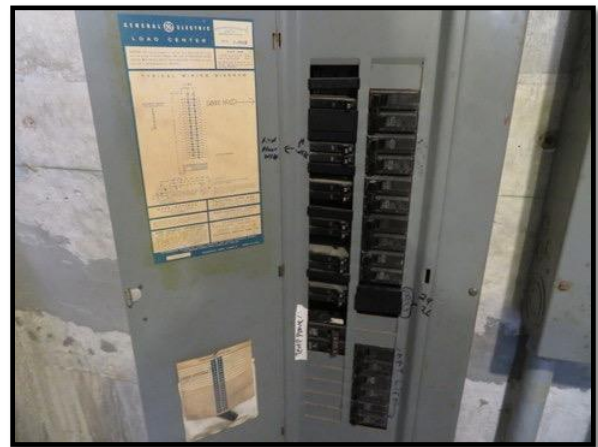
The Association maintains common electrical systems. The common area main electrical panels are primarily original, in satisfactory operational condition and range in capacity up to 600 amps. Electrical systems have a long useful life. Not all components will fail simultaneously and therefore periodic repairs and partial replacements are likely as the system ages. The Association should budget for partial replacements by 2026 and every 10 years thereafter. The exact times and costs will vary.

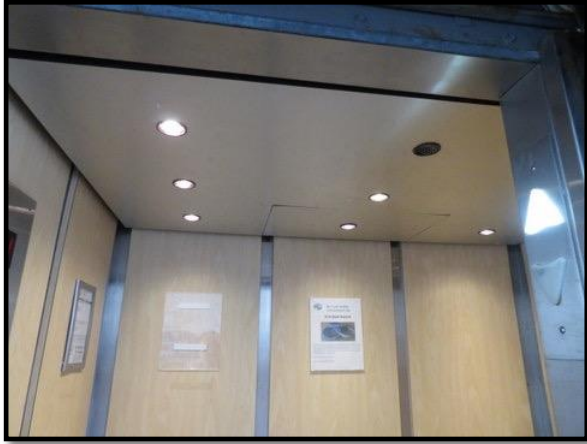
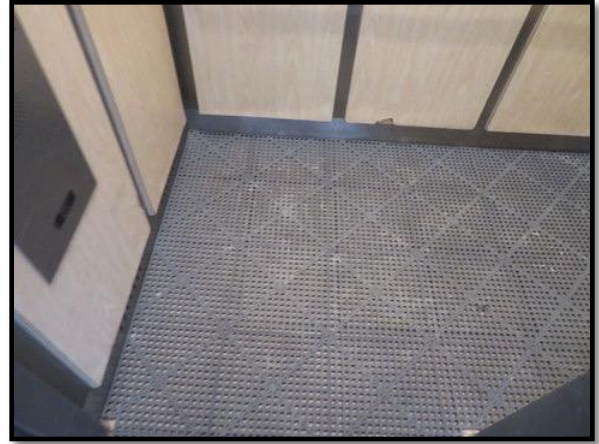
The Association maintains an elevator. The cab finishes comprise tile floors, lighted ceiling and wood panel walls. The cab finishes are in fair condition. The exact age is unknown. Cab finishes have a useful life of up to 15 years. The Association should budget for replacements by 2025 and again by 2040.

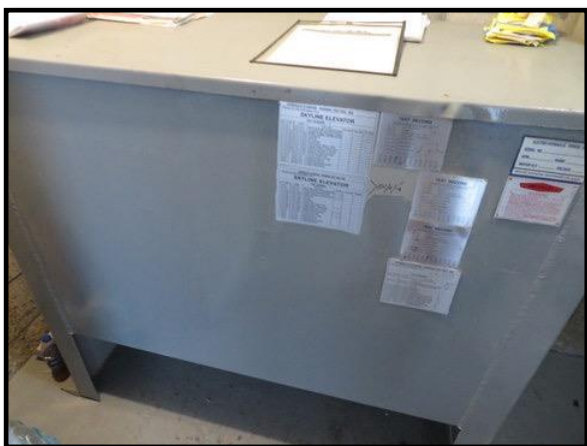
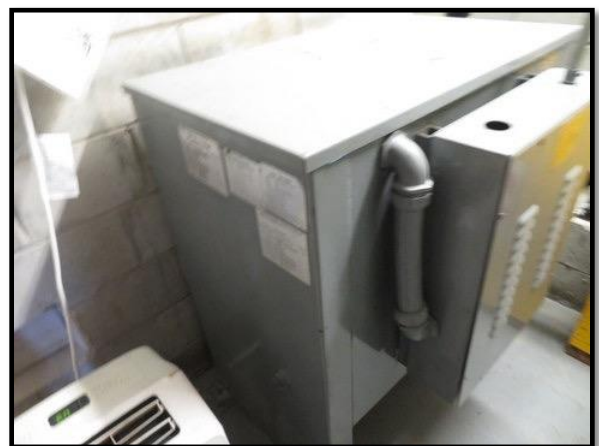
Figure 1 – Elevator Pump

The Association utilizes a 2,000 pound capacity hydraulic elevator to serve five floors. Hydraulic elevator components include a cylinder, pump and controls. These components are original and in fair reported condition. The useful lives of these components vary up to 30 years. However, factors such as design, usage, environmental, and maintenance frequency will increase or decrease lifecycle. However, the Association should budget for replacements by 2043. The estimate of cost in 2023 is for pump repairs. The elevator's safety equipment should be brought up to the latest code. Fire service features should be brought up to accordance with the requirements of the applicable ASME A17.1, Safety Code for Elevators and Escalators. The Association should contract with an independent elevator consultant to develop specifications for elevator replacement proposals.

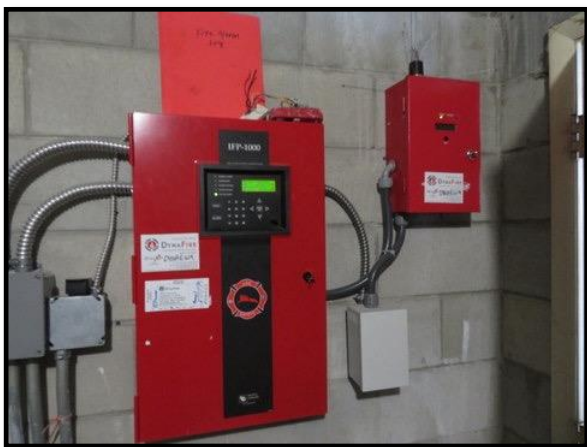
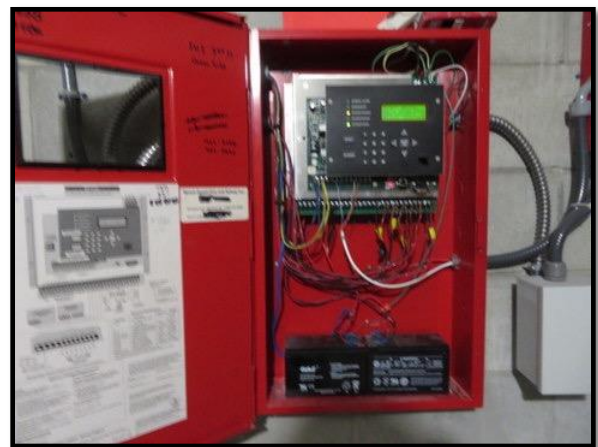
Figure 1 – Control Panel

The Association maintains a fire protection system for each building. A fire protection system comprises a main panel that controls emergency devices such as annunciators and pull boxes. The system utilizes a battery backup. The fire protection systems are and in satisfactory operational condition at various ages. Changes in building codes and/or technology may make a replacement necessary and/or desirable prior to the useful life of up to 25 years. Sea Coast No. 2 should budget for replacements by 2036. Annual fire protection system inspections are required by the National Fire Protection Association (NFPA) 722 Standards. The Association should fund interim replacement of exit signs and smoke detectors through the operating budget as needed.

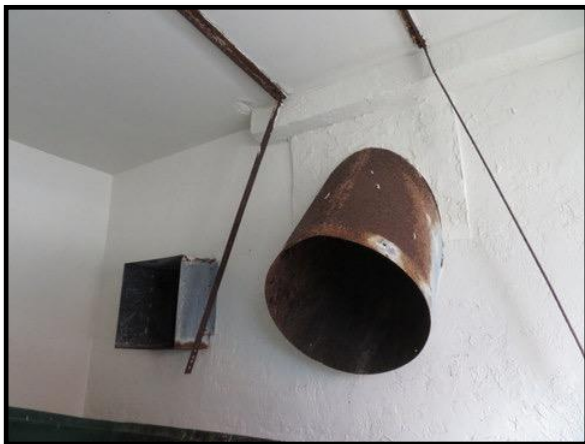
Figure 1 – Bottom of Chute

Sea Coast No. 2 utilizes a trash chute. The trash chute is original and in fair condition overall. Areas of rust located at the bottom are noted in the following picture.

Trash chutes in coastal areas have a useful life of up to 55 years. The Association should pressure wash the chutes annually through the operating budget to maximize the useful life. Sea Coast No. 2 should budget for partial replacement of the bottom section in 2024. The estimate of cost includes replacement of the doors on each floor.

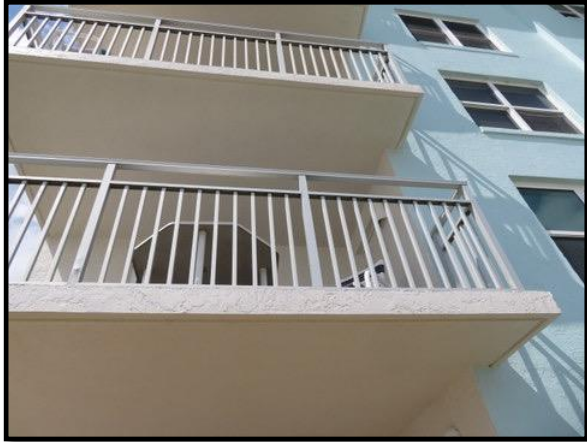
Figure 1 – Balcony Undersides

The balconies and breezeways of Sea Coast No. 2 comprise approximately 24,690 square feet of concrete surface. The balconies and breezeways are in good condition overall. The balconies and breezeways utilize a urethane waterproofing system. Balconies and breezeways have a long useful life with the benefit of periodic maintenance. Concrete cracks and spalling occur from the expansion of the reinforcing steel bars due to corrosion. Concrete corrosion is caused by rainwater and chlorides penetrating the surface of the concrete and contacting the embedded steel reinforcement bars. Failure to maintain the balconies can lead to costly repairs.

Concrete repairs include replacing compromised reinforcing within associated cracks and spalls. Cracks should be repaired with a gravity feed epoxy. Sea Coast No. 2 should use a hybrid coating consisting of a urethane base coat with a textured acrylic topcoat. The proper way to apply coatings is to remove and reinstall the railings. Waterproof coatings applied to horizontal walking surfaces should meet or exceed the minimum requirements for pedestrian traffic bearing capacity and slip resistance.

The Association should budget for waterproof coatings, cant bead and partial concrete repairs as needed by 2033 and every 10 years thereafter in conjunction with paint finish applications. The cant bead is the seal between the wall and floor surfaces. Sea Coast No. 2 should also budget for removal of the existing coatings by 2033 and every 20 years thereafter.

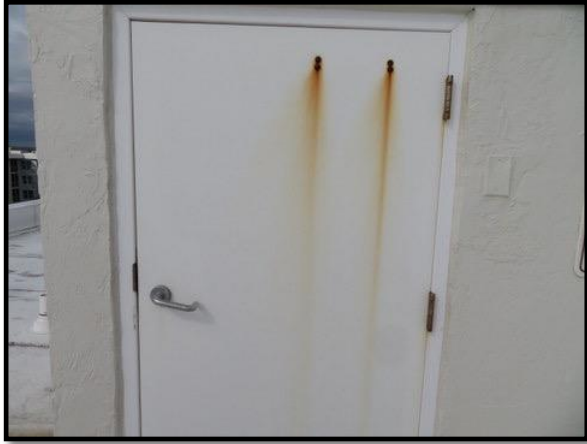
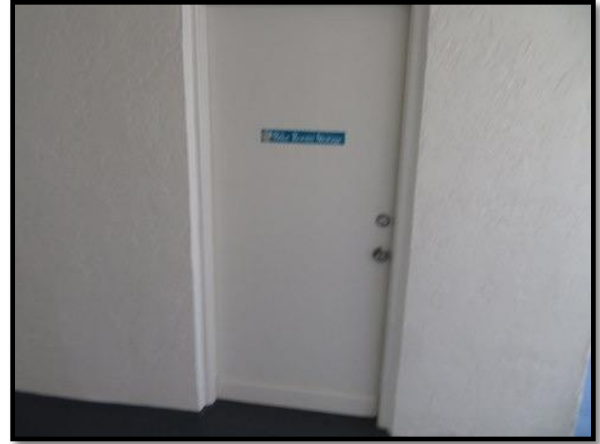
Sea Coast No. 2 maintains 45 common doors. Four of which are fired rated. The common doors are in fair overall condition at various ages. Doors have an estimated useful life of up to 25 years. Based on the varied ages, the Association should budget for phased replacement of up to nine common doors every five years beginning by 2028.

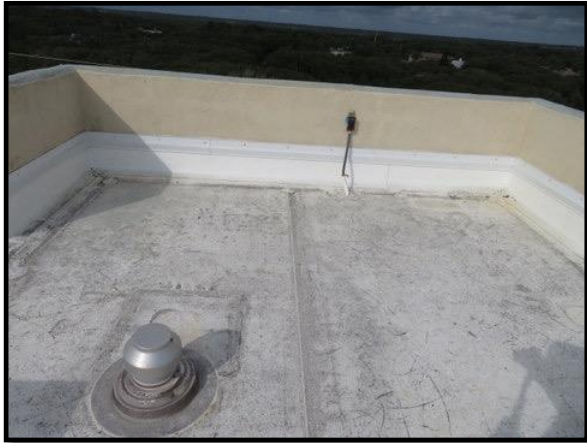
The paint finishes are in fair to good overall condition at an age of less than one year. Based on recommendations by United Engineering Consultants, Inc., Sea Coast No. 2 should budget for the beachside paint finishes every five years and the remaining paint finishes have a useful life of up to 10

Figure 1 – Rooftop Knee Wall Needs New Paint

years. In addition, phased paint removal applications are included beginning by 2033 and concluding by 2043. Dry film thickness (DFT) above 20 mils can be problematic.

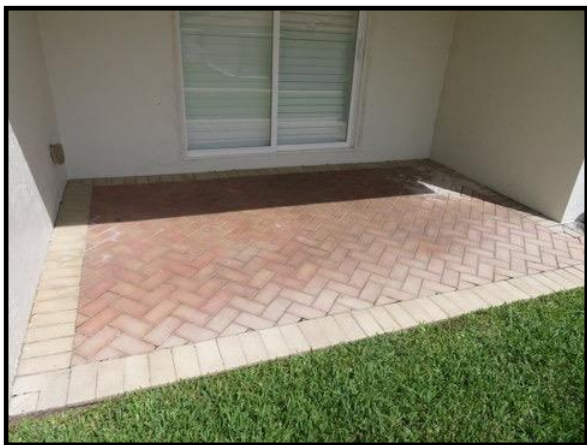
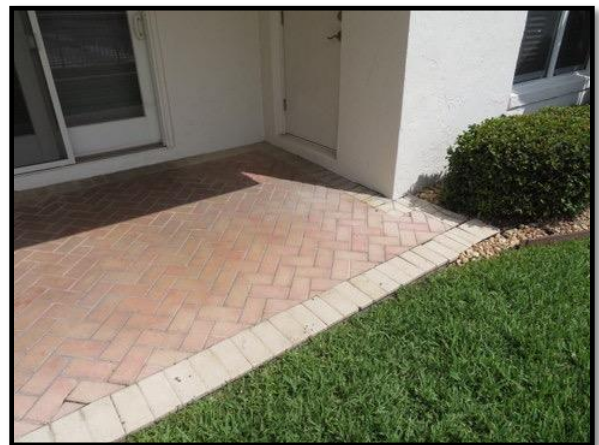
The patios comprise approximately 1,800 square feet of pavers. Pavers have a useful life from 20- to 30-years with the benefit of ongoing maintenance that includes pressure washing, resetting as needed, an application of sand between the pavers followed by sealer applications every three- to five-years to preserve the color and minimize repairs. Sea Coast No. 2 should budget for this maintenance activity through the operating budget.

The need to eventually replace the pavers may be desired based on aesthetics. The Association should fund for patio paver replacements by 2033.

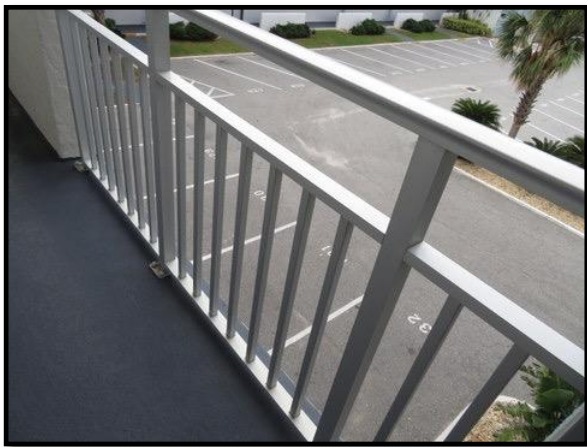
Figure 1 – Breezeway Railings

The Association maintains approximately 3,690 linear feet of aluminum railings. The railings are in fair overall condition at an age of 14 years. The finish on aluminum fences is relatively maintenance free. While aluminum doesn't rust, it does corrode over time. Aluminum railings have a useful life of up to 35 years. The major concern with railings is safety. Sea Coast No. 2 can maximize the useful life by repairing connections and fasteners promptly when and if they fail. These activities should be funded through the operating budget on an as needed basis. The Association should budget for railing replacements by 2033 in conjunction with the next restoration project. Sea Coast No. 2 should make sure stainless-steel fasteners are used.

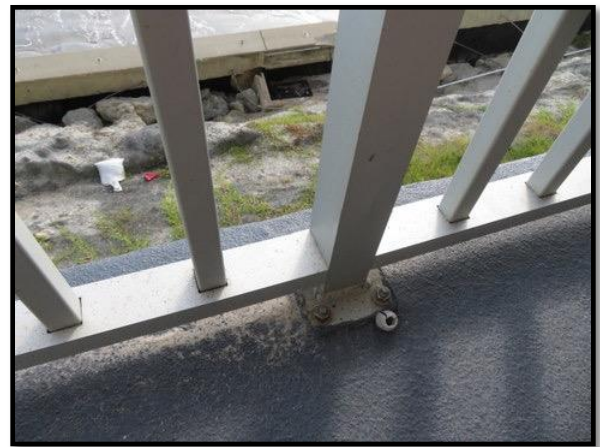
Figure 2 – Balcony Railing Caps Missing

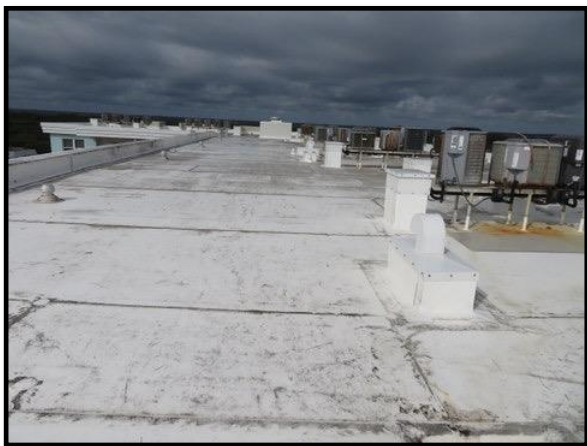
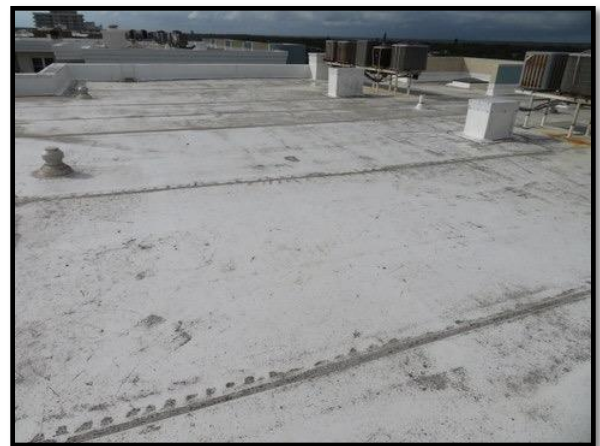
The Association maintains 262 squares of flat roof. The flat roof is in good condition at an age of three years. Flat roof coverings have a useful life from 15- to 20-years.

There are several different options for flat roofs. The estimate of cost is based on a TPO roofing system. TPO can be mechanically attached, fully adhered, self-adhered, ballasted, or induction welded. The advantages of TPO are strong heat welded seams and a highly reflective surface saving on energy costs. The Association should budget for replacement of the flat roof system by 2040.

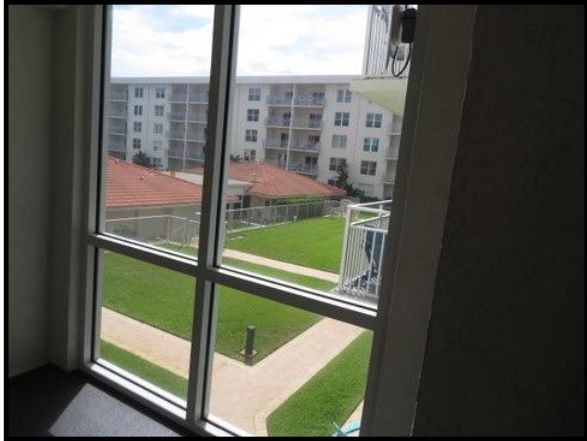
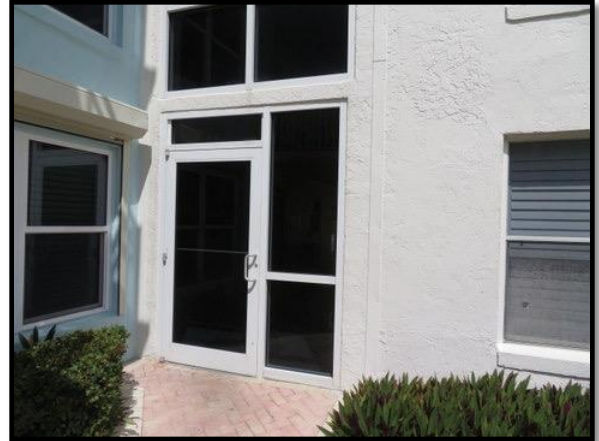
The common windows and glass doors comprise 830 square feet. The windows and glass doors are in good overall condition at an age of 13 years. Windows and glass doors of this type have a useful life of up to 45 years. Sea Coast No. 2 should budget for replacement of the windows and glass doors by 2049. The windows should meet the Florida Building Code for impact resistance. The estimate of cost includes an allowance for engineering fees.

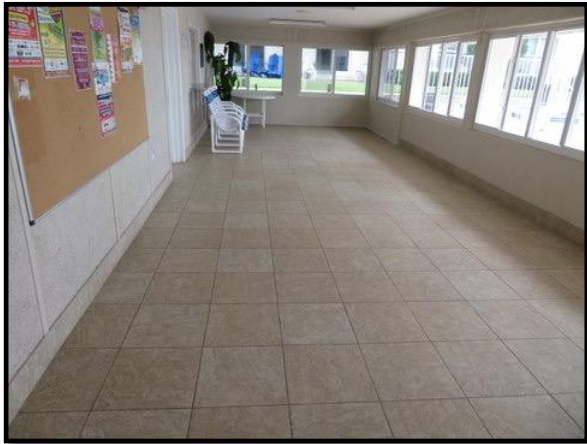
Figure 1 – Tile Floor

The Association maintains 1,635 square feet of tile floor coverings. The tile floors are in good overall condition. The exact age is unknown. Tile floors have a useful life of up to 25 years and beyond with the benefit of periodic maintenance. Periodic maintenance includes cleaning and partial replacements of cracked tiles as needed. Replacement is often predicated on the discretion of the active board's opinion of the need to update the appearance. Based on condition, the Association should anticipate replacement of the tile floor by 2033.

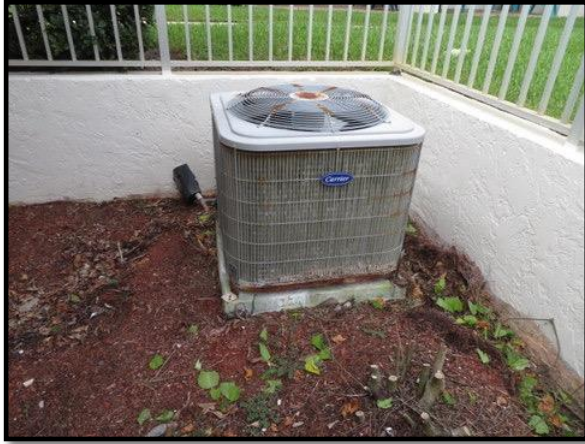
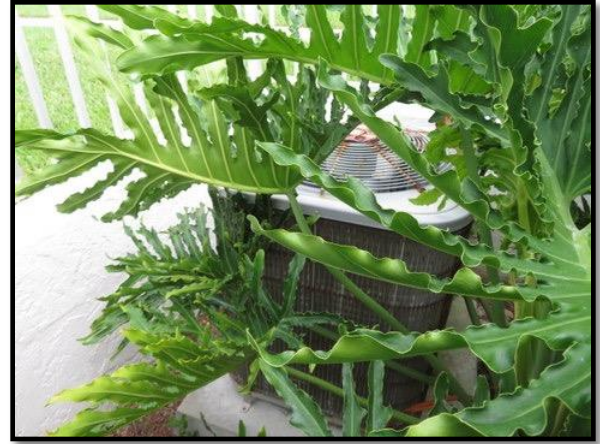
The clubhouse utilizes two split systems for heating, ventilating and air conditioning. The split systems were operational at the time of the site visit at various ages. Split systems have a useful life from 8- to 12-years. The Association should budget for replacement by 2024 and every 10 years thereafter.

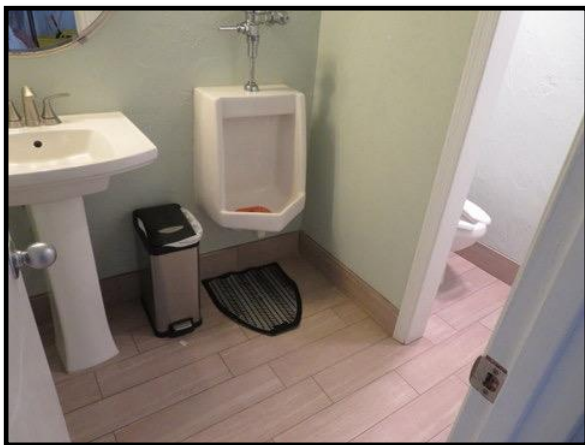
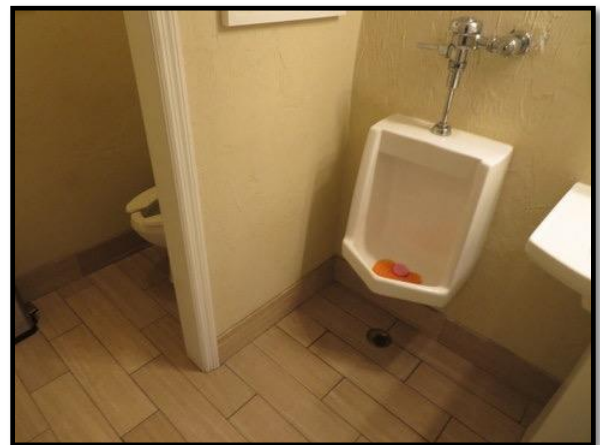
There are four rest rooms located within the clubhouse. The rest rooms comprise tile floor plumbing and electrical fixtures. The rest rooms are in fair condition. The exact ages are unknown. These rest room components have a useful life of up to 25 years. The Association should budget for renovations of the rest rooms by 2033 in conjunction with the plumbing and tile floor.

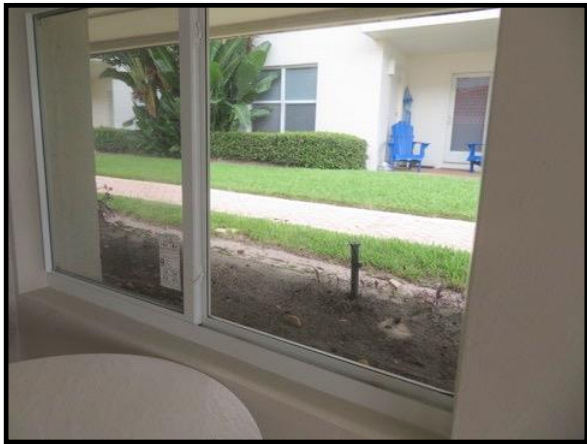
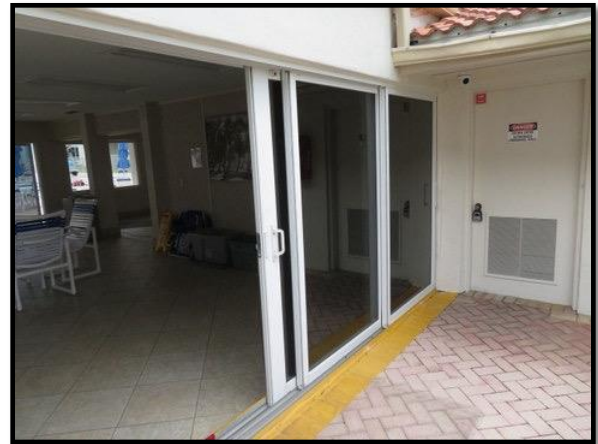
The windows and glass doors of the clubhouse comprise 800 square feet. The windows and glass doors are original and in fair overall condition. Windows and glass doors of this type have a useful life of up to 45 years. The need to replace windows can be due to various reasons such as consistency in style and condition. There will be a cost savings with coordinated replacement. The Association should budget for replacement of the windows and doors by 2028.

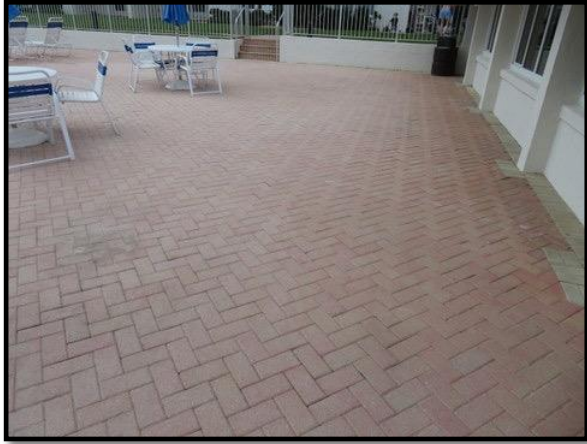
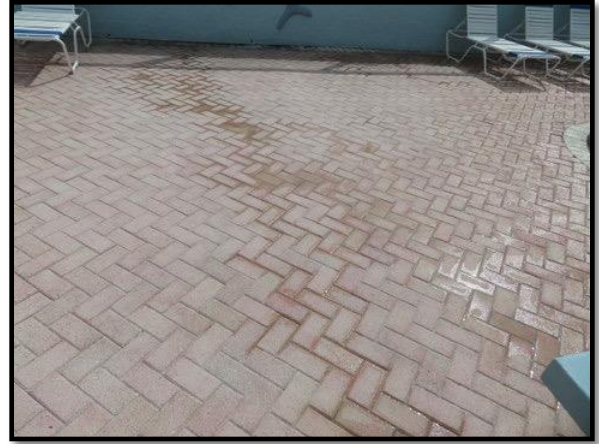
The pool deck comprises approximately 15,390 square feet of pavers. The quantity includes the sidewalks. The pavers are in fair overall condition at an age of 20 years. Pool deck pavers have a useful life from 20- to 30-years with the benefit of periodic maintenance.

Periodic maintenance includes pressure washing, resetting as needed and an application of sand between the pavers followed by a sealer application every three years. The Association should budget for this maintenance activity beginning in 2029. The sealer quantity includes the new paver deck. The need to eventually replace the pavers may be desired based on aesthetics. The Association should budget for replacement of the pavers by 2026. Interim repairs should be funded through the operating budget as needed.

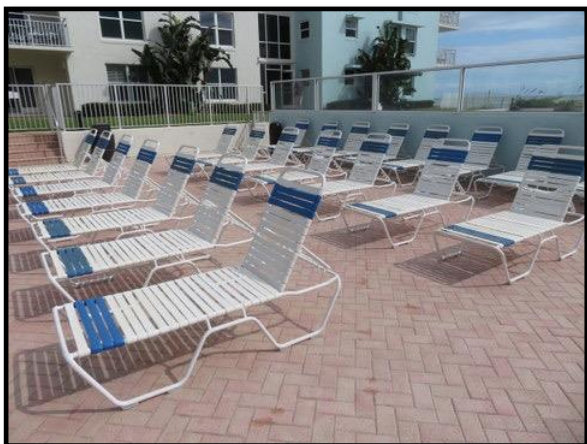
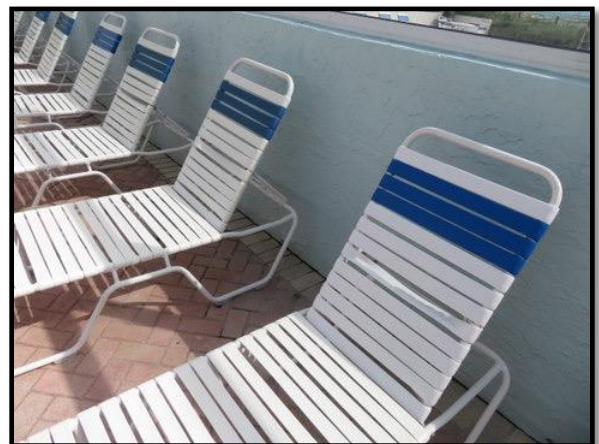
The pool furniture includes umbrellas, lounges, tables and chairs. The pool furniture is in fair condition overall at an age of five years.

The pool furniture has a useful life from 5- to 10-years. The Association should budget for replacement by 2025 and every seven years thereafter. The Association should fund interim restrapping through the operating budget as needed.

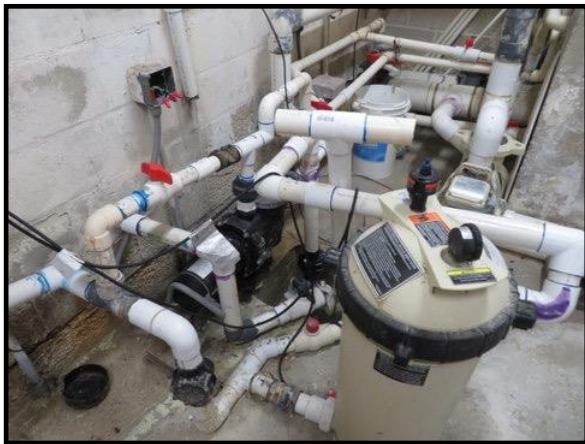
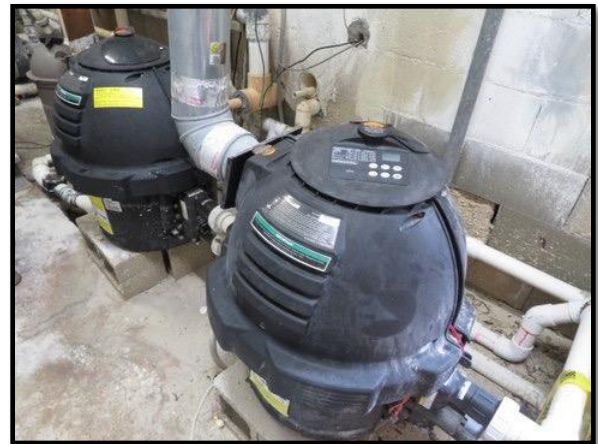
The mechanical equipment includes two heaters, pumps, filters and chlorinators. The mechanical equipment is in fair overall condition at various ages. The pool equipment has a useful life from 5- to 10-years with the benefit of ongoing maintenance. This ongoing maintenance includes partial replacements of the pumps, filters and chlorinators as needed. The Association should fund these minor partial replacements through the operating budget. The Association should budget for phased replacements beginning by 2026 and concluding by 2027 prior to the pool finishes. Subsequent phased replacements are likely every five years thereafter. The estimate of cost in 2023 is approximate and for a pool heater.

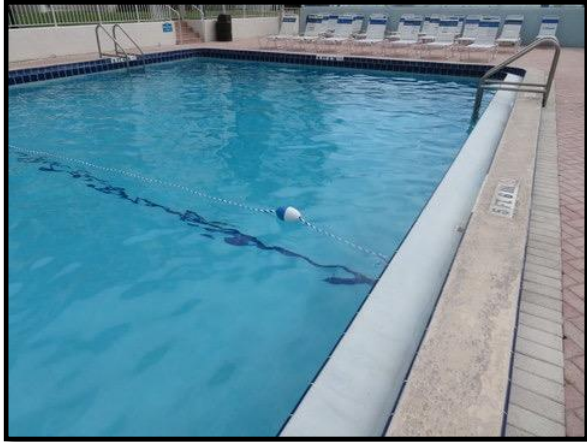
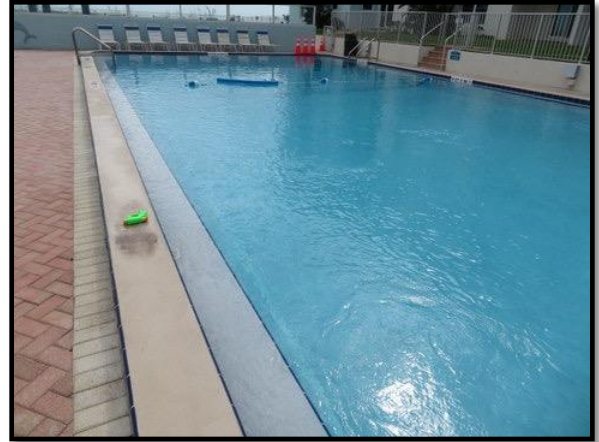
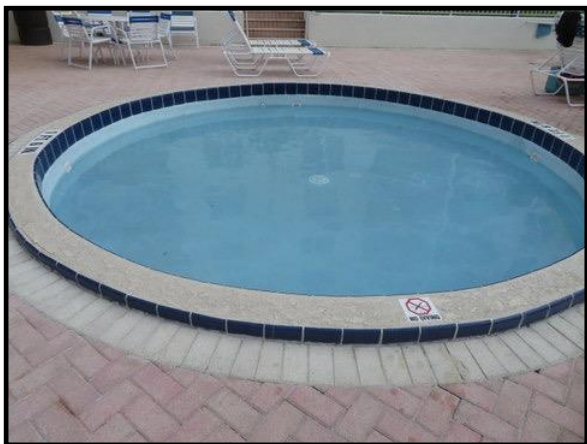
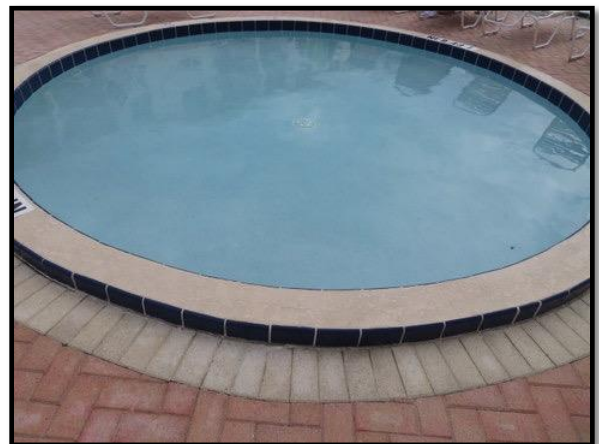
The finishes at the pool walls and floors surfaces are in fair overall condition at an age of five years. Pool finishes have an anticipated useful life from 10- to 15-years. The Association should budget for resurfacing of the wall and floor areas, as well as replacement of the pool waterline tile, by 2028 and every 10 years thereafter. Typically, minor upgrades will be needed to bring the pool up to current code. Potential repairs to the underlying pool structure may raise the estimate of cost.

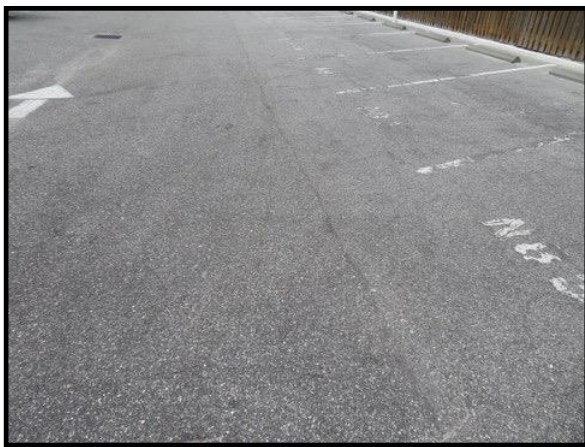
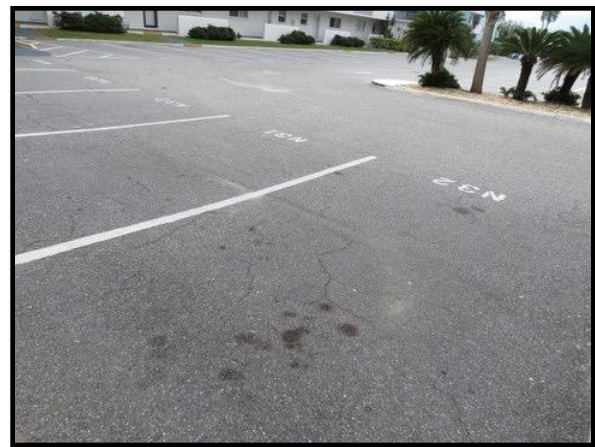
The Association maintains approximately 4,555 square yards of asphalt streets and parking areas. The asphalt pavement is in fair overall condition at an age of 10 years. Asphalt pavement comprises multiple layers. Typically the top layer or surface course deteriorates over time and can be milled or removed and overlaid or replaced. The following diagram depicts typical pavement layers.

The Association should budget for a mill and overlay of the pavement by 2032. The Association should retain an engineer for quality control.

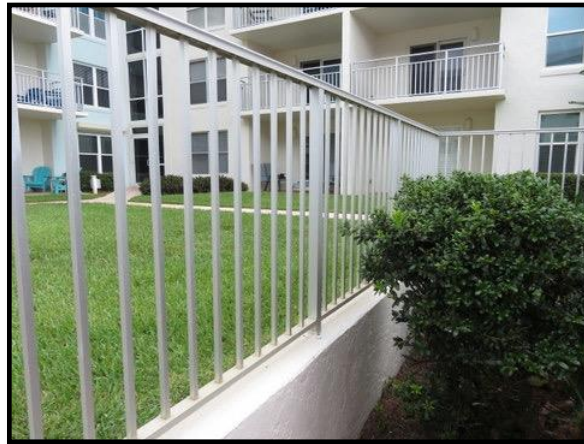
Figure 1 – Pool Area Railing

The Association maintains 430 linear feet of railings that surround the pool area and 550 linear feet of aluminum railings located atop the sea wall. The pool area railings are in fair overall condition at an age of 17 years. The Association should budget for the pool railing replacements by 2041. Management and the Board report that the Association plans to replace the sea wall railings due to storm damage in the near term funded through a special assessment. The Association should fund for partial replacement of up to eighty percent (80%) of the sea wall railings by 2053.

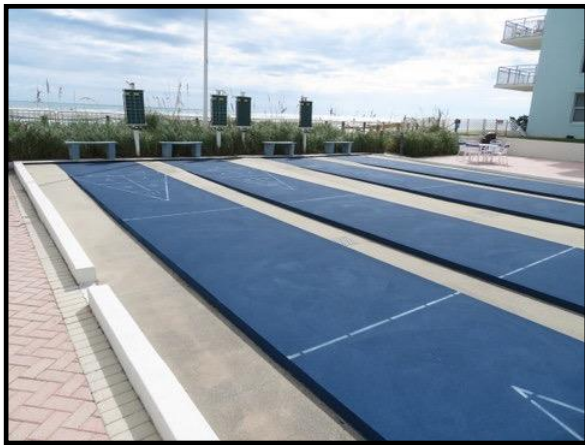
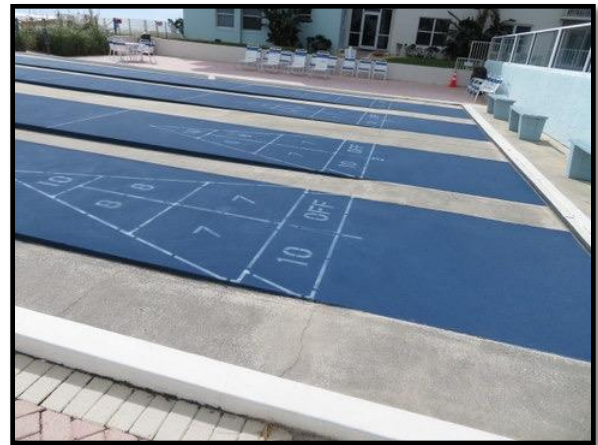
The Association maintains approximately 2,150 square feet of shuffleboard courts. These concrete courts are in fair overall condition. Concrete is durable and this application has a useful life of up to 65 years. However, it will eventually deteriorate from natural weathering. Proper mix designs and installation are also factors that can lead to premature deterioration. The Association should budget for replacement of the shuffleboard courts by 2036. Interim color coat applications should be funded through the operating budget as needed.

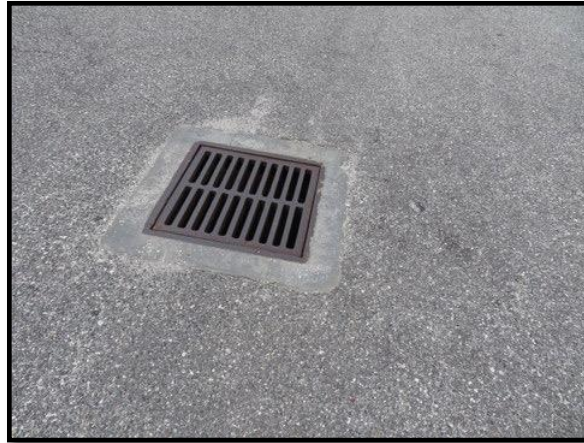
Figure 1 – Catch Basin

The overall reported condition of the stormwater structures is good. Stormwater systems have a long useful life with the benefit of ongoing maintenance. Achieving this useful life typically requires interim capital repairs or partial replacements. Maintenance of stormwater systems is required in every municipality as a condition for use of the land to prevent adverse impacts on adjoining properties. The Association should routinely keep the stormwater system clear every three- to four-years beginning in 2026.
