# **SEA COAST GARDENS III CONDOMINIUM**

## **BUILDING S.B. 4-D MILESTONE INSPECTION REPORT**

PROJECT NO. 23-1311

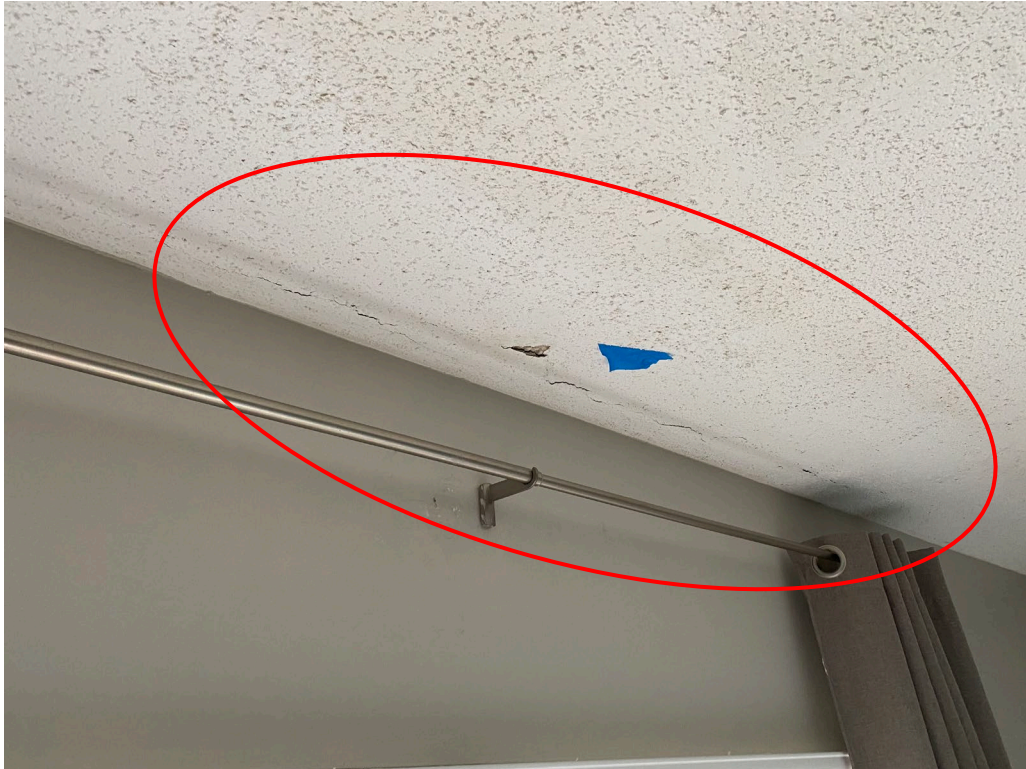
The interior slabs were inspected and spalling damage was detected on the ceiling of the master bedroom at units 106, 108, 109 and 111. The size of the spalling was between 1 and 6 square feet and was located on the ceiling above the bedroom window opening.

**Photograph #1 – Typical interior ceiling concrete spalling damage**

In our opinion, the corrosion related concrete damage identified is not substantial structural deterioration at the time of the inspection. The damage identified is small in size per location and the building structure as a whole remains safe to occupy. It is recommended that the damage identified be repaired as the damage can continue to worsen and become more structurally significant. The repairs should be completed in accordance with the Florida Building Code, International Concrete Repair Institute and ACI. Phase II exploratory work is not recommended.

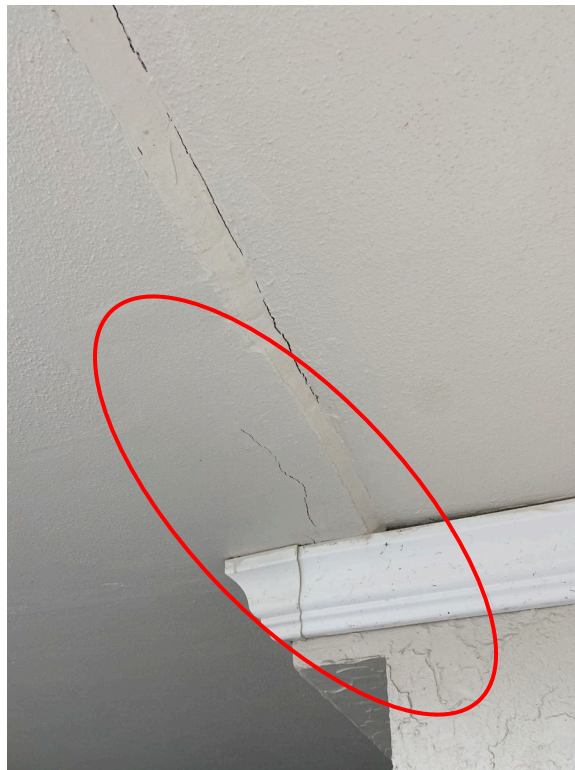
**Walkways and Stairwells (Structural):** The walkways and stairwells are in excellent condition with limited spalling damage identified. 14 locations of small size concrete spalls were detected at the walkways and within the common areas rooms, such as laundry and utility rooms. Of the 14 locations, 9 were located on the ceiling of the walkways and laundry room slabs. The remaining areas were located on the walls and the topside of the slabs.

**Photograph #2 – Typical slab spalling damage at walkway**
