**SEA COAST  
MANAGEMENT NO. 3., INC.  
STRUCTURAL INTEGRITY RESERVE  
STUDY (SIRS)**

**For 30-Year Projection Period: FY 2023 through FY 2053**

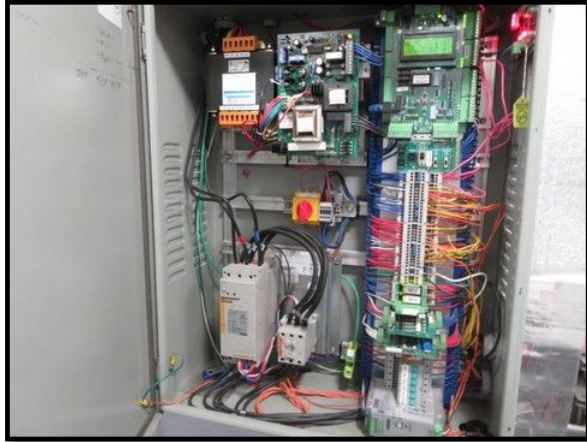
Figure 5 – Elevator Controls

The Association utilizes two 2,000-pound capacity hydraulic elevators to serve five floors. Hydraulic elevator components include a cylinder, pump and controls. These components are in fair overall reported condition. The useful lives of these components vary up to 30 years. However, the Association should budget for a modernization of all the elevator components by 2043. Fire service features should be brought up to accordance with the requirements of the applicable ASME A17.1, Safety Code for Elevators and Escalators. The Association should contract with an independent elevator consultant to develop specifications for elevator replacement proposals.

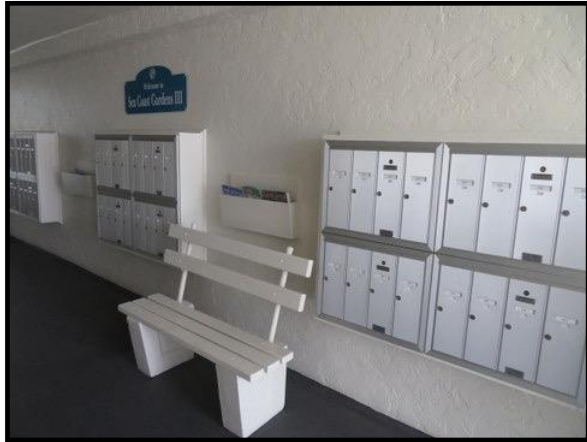
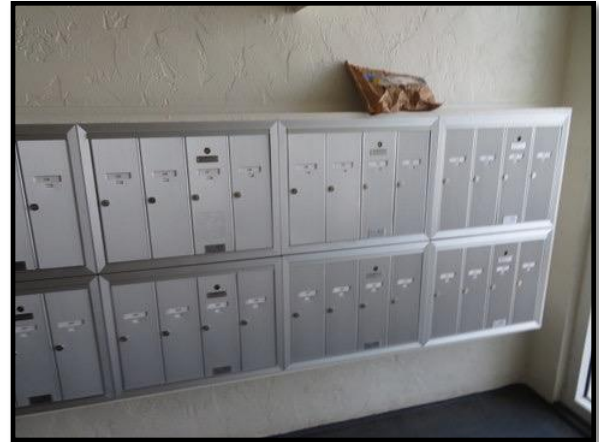
Sea Coast No. 3 maintains 85 mailboxes. The mailboxes are in good at an age of less than one year. Metal mailboxes have an anticipated useful life of up to 30 years. The Association should budget for mailbox replacements by 2053.

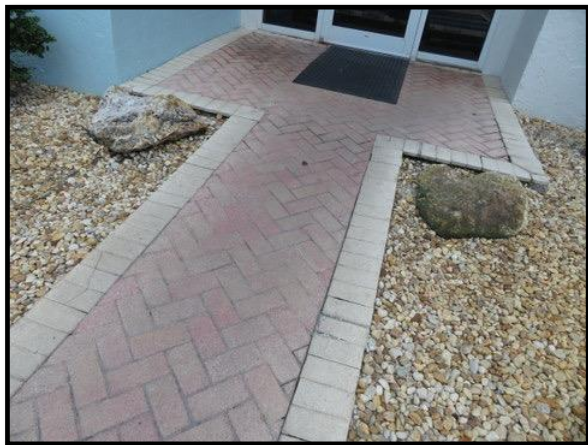
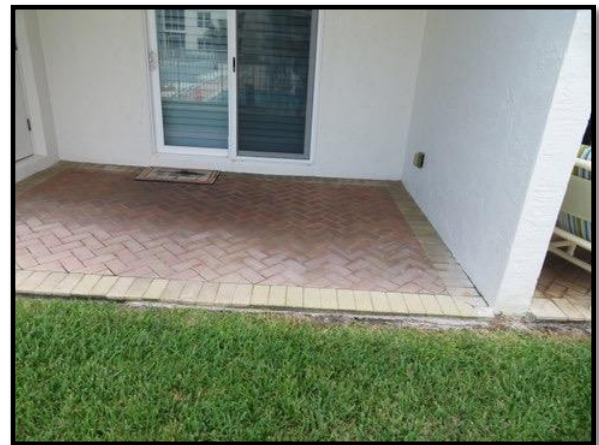
The patios comprise approximately 1,800 square feet of pavers. Pavers have a useful life from 20- to 30-years with the benefit of ongoing maintenance that includes pressure washing, resetting as needed, an application of sand between the pavers followed by sealer applications every three- to five-years to preserve the color and minimize repairs. Sea Coast No. 3 should budget for this maintenance activity through the operating budget.

The need to eventually replace the pavers may be desired based on aesthetics. The Association should fund for replacements by 2034.

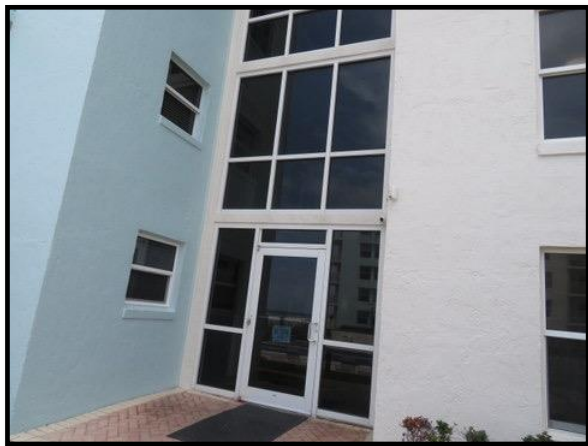
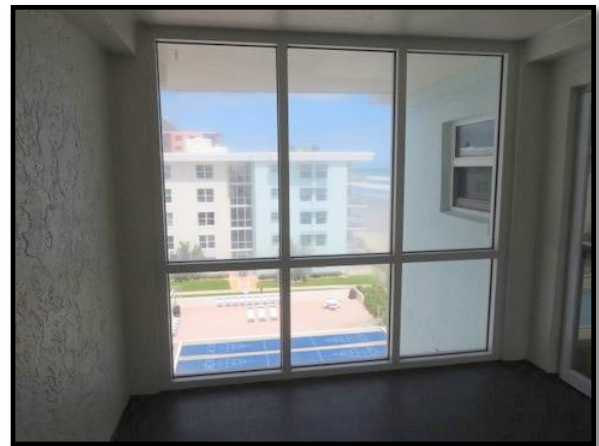
The common windows and glass doors comprise 830 square feet. The windows and glass doors are in good overall condition at an age of 13 years. Windows and glass doors of this type have a useful life of up to 45 years. Sea Coast No. 3 should budget for replacement of the windows and glass doors by 2049. The windows should meet the Florida Building Code for impact resistance. The estimate of cost includes an allowance for engineering fees.

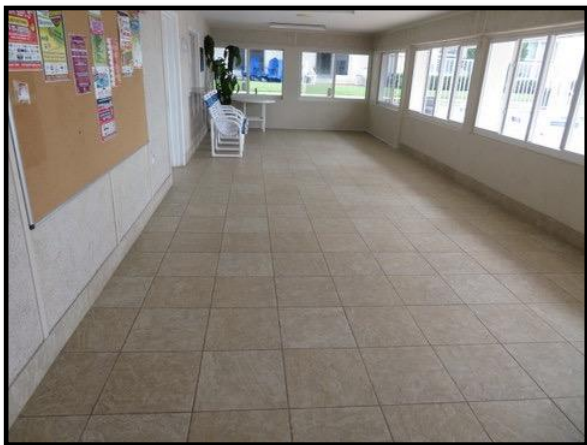
The Association maintains 1,635 square feet of tile floor coverings. The tile floors are in good overall condition. The exact age is unknown. Tile floors have a useful life of up to 25 years and beyond with the benefit of periodic maintenance. Periodic maintenance includes cleaning and partial replacements of cracked tiles as needed. Replacement is often predicated on the discretion of the active board's opinion of the need to update the appearance. Based on condition, the Association should anticipate replacement of the tile floor by 2033.

Figure 1 – Tile Floor

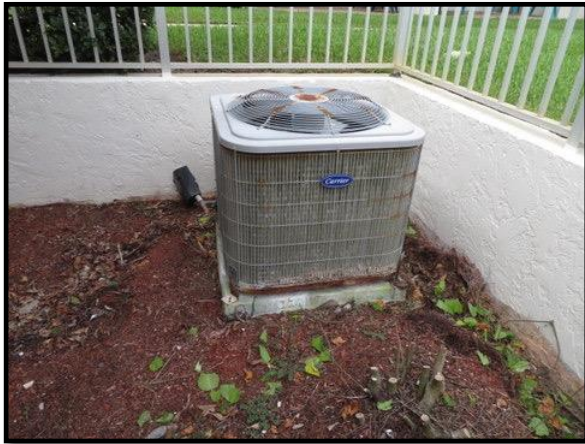
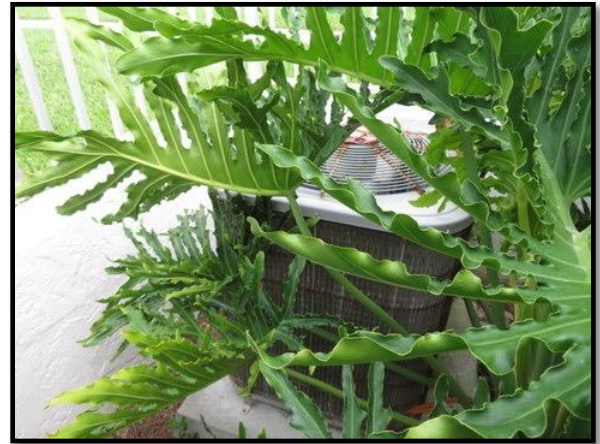
The clubhouse utilizes two split systems for heating, ventilating and air conditioning. The split systems were operational at the time of the site visit at various ages. Split systems have a useful life from 8- to 12-years. The Association should budget for replacement by 2024 and every 10 years thereafter.

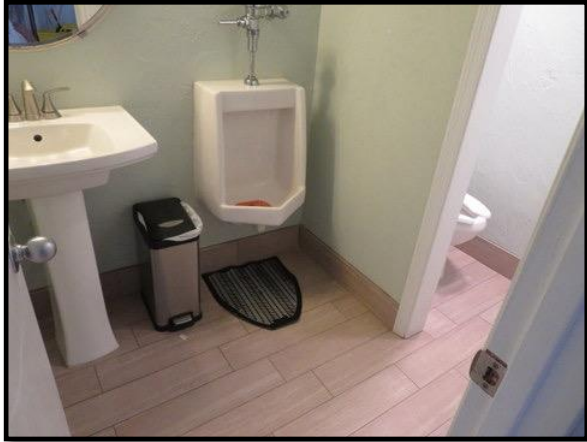
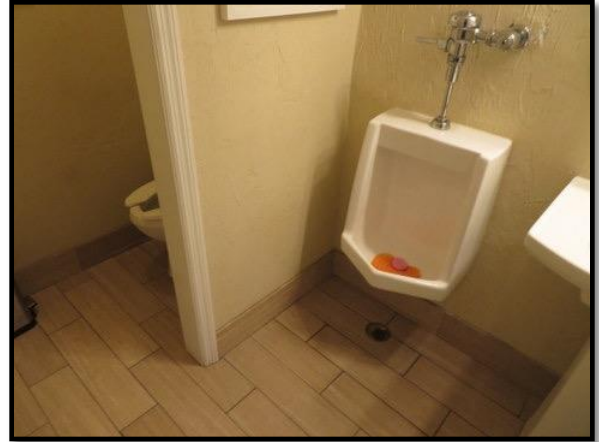
There are four rest rooms located within the clubhouse. The rest rooms comprise tile floor plumbing and electrical fixtures. The rest rooms are in fair condition. The exact ages are unknown. These rest room components have a useful life of up to 25 years. The Association should budget for renovations of the rest rooms by 2033 in conjunction with the plumbing and tile floor.

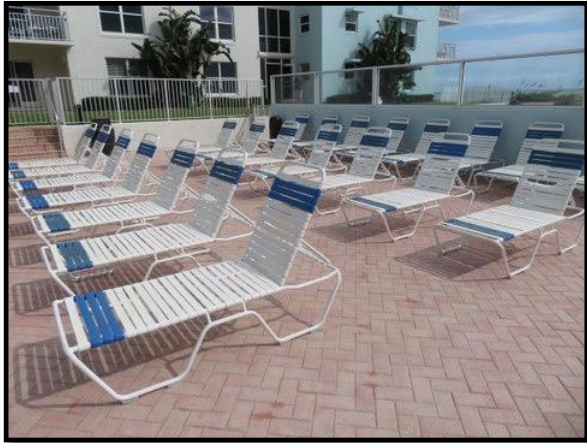
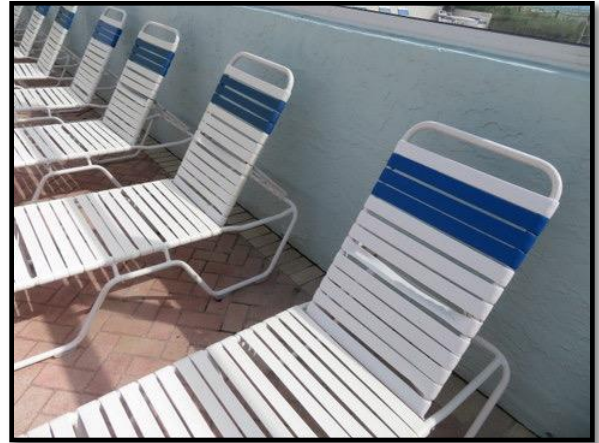
The pool furniture includes umbrellas, lounges, tables and chairs. The pool furniture is in fair condition overall at an age of five years. The pool furniture has a useful life from 5- to 10-years. The

Association should budget for replacement by 2025 and every seven years thereafter. The Association should fund interim restrapping through the operating budget as needed.

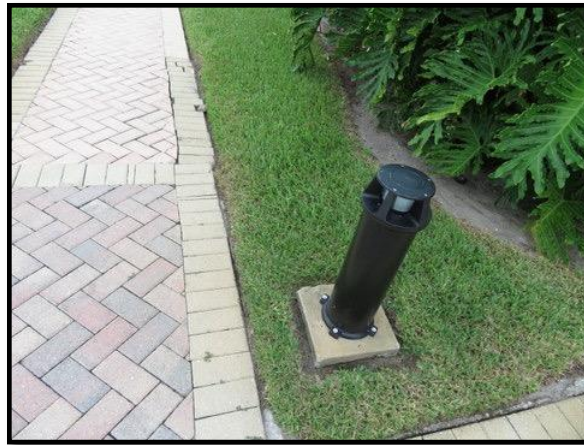
Figure 1

The Association maintains 22 bollard light fixtures located along the sidewalks. The bollards are in satisfactory operational condition at an unknown age. These bollards have an anticipate useful life of up to 20 years. Based on the condition, the Association should budget for their replacement by 2030 and again by 2050. Interim replacement of light bulbs and/or fixtures should be funded through the operating budget on an as needed basis.

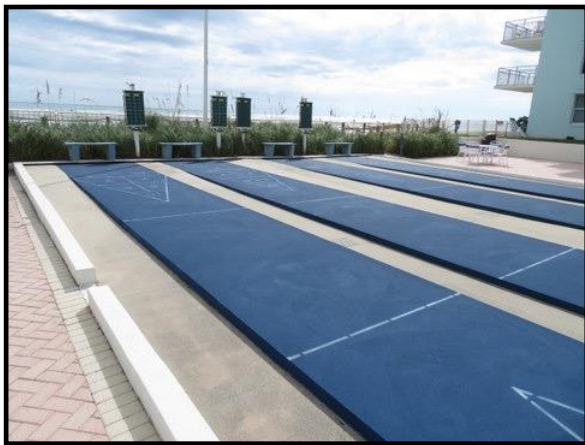
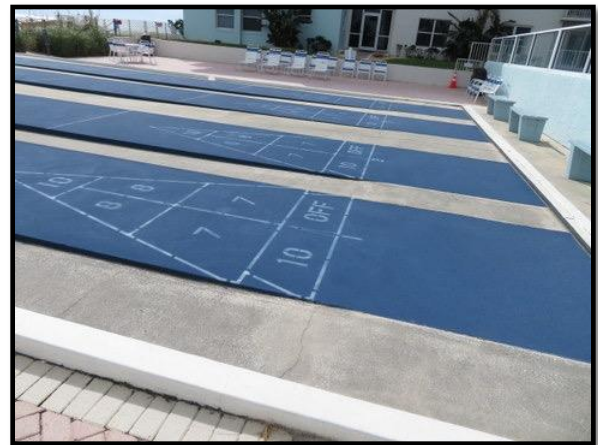
These concrete courts are in fair overall condition. Concrete is durable and this application has a useful life of up to 65 years. However, it will eventually deteriorate from natural weathering. Proper mix designs and installation are also factors that can lead to premature deterioration. The Association should budget for replacement of the shuffleboard courts by 2036. Interim color coat applications should be funded through the operating budget as needed.
