Revised
FULL RESERVE STUDY

**Sea Coast
Management No. 2, Inc.**

New Smyrna Beach, Florida
Inspected - July 23, 2021
Revised - December 13, 2021

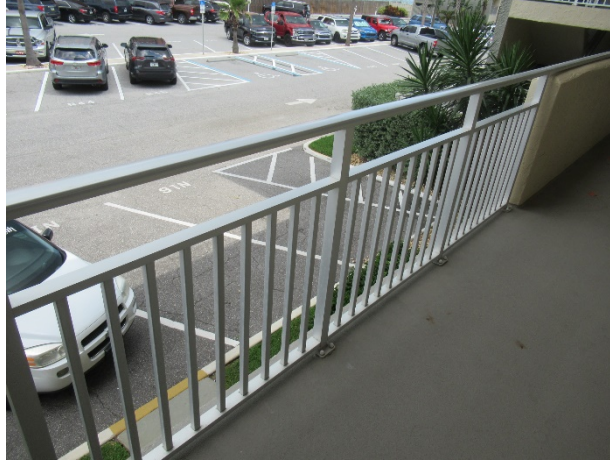
History: Unknown. Management informs us that the railings will need to be replaced during the next concrete restoration project due to changes in the building codes.

Condition: Good to fair overall

Typical railings at the breezeways and balconies

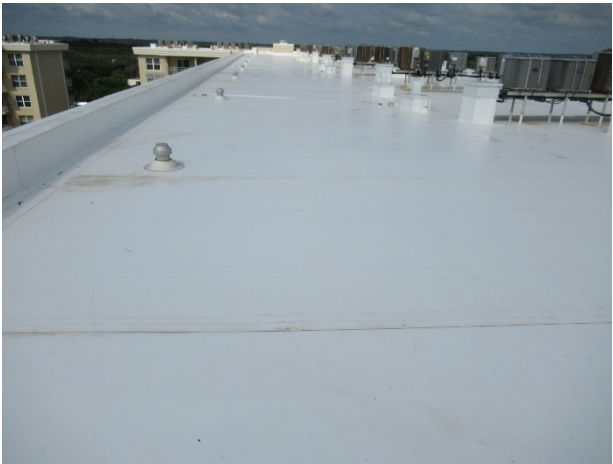
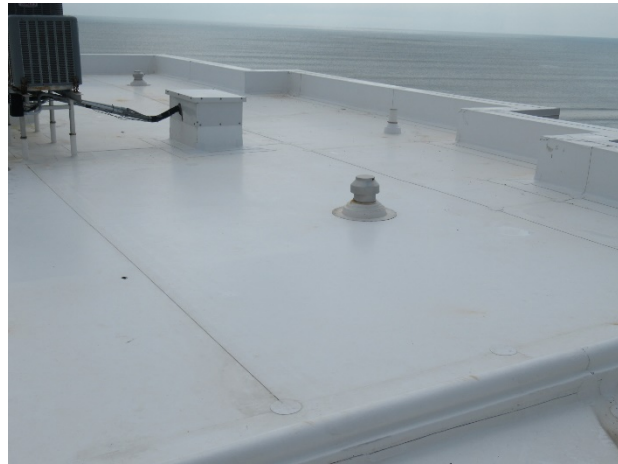
Condition: Good overall with minor areas of stains and ponding water.

Thermoplastic roof overview

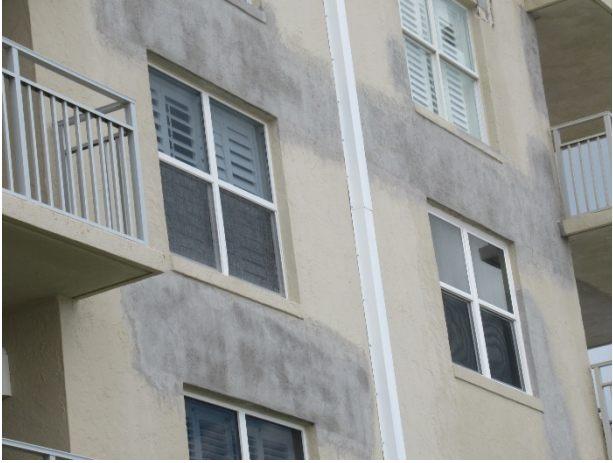
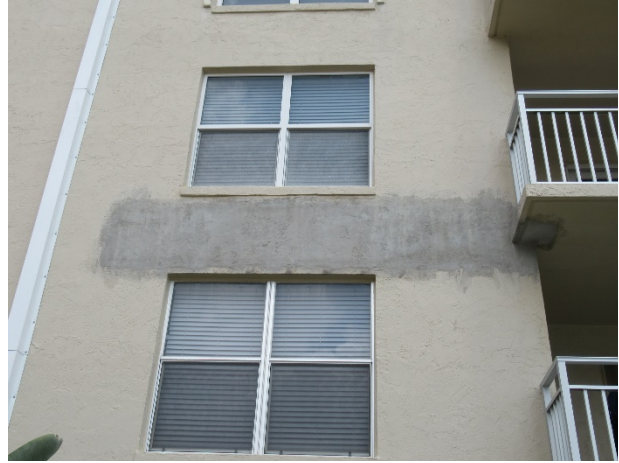
Recent stucco repairs

Recent stucco repair

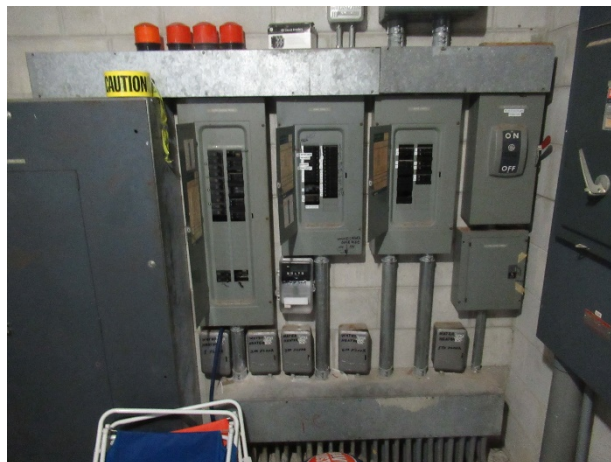
Condition: Reported satisfactory with the need for near-term updates

Electrical system components

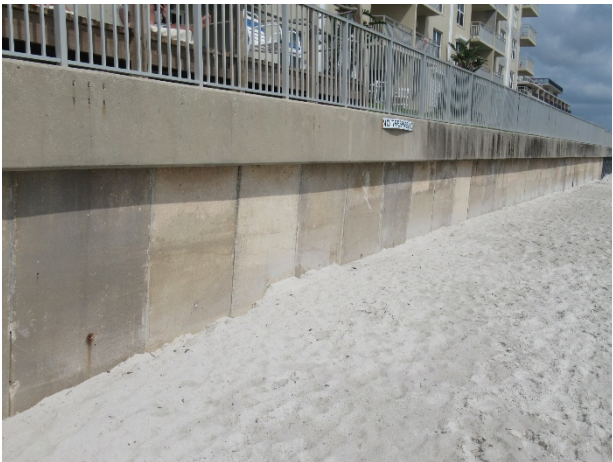
Conditions: The bulkheads are in good to fair condition based on our non-invasive inspection, with no significant deterioration visually evident. We note one area of wash-out at the base of the wall near a drain.

Original concrete bulkhead

History: The original concrete bulkhead had one section of approximately 123 linear feet replaced with vinyl within the past ten years. Management informs us that the remaining section of approximately 162 linear feet of concrete bulkhead will need to be replaced in the near-term.

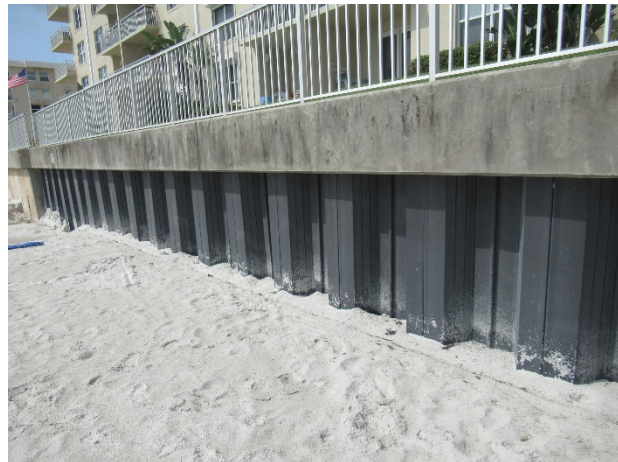
Vinyl section of bulkhead

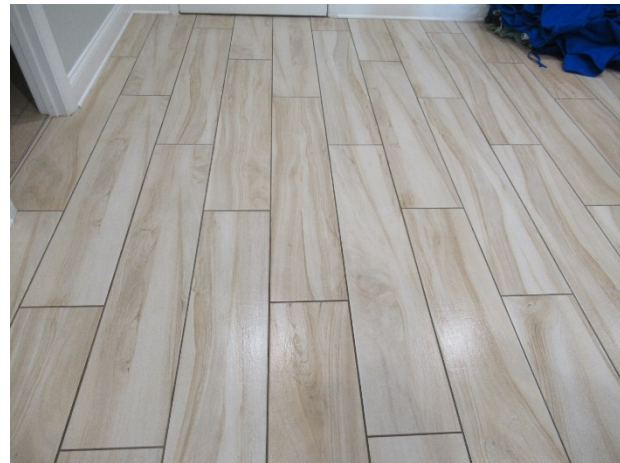
Tile Flooring replaced in 2019

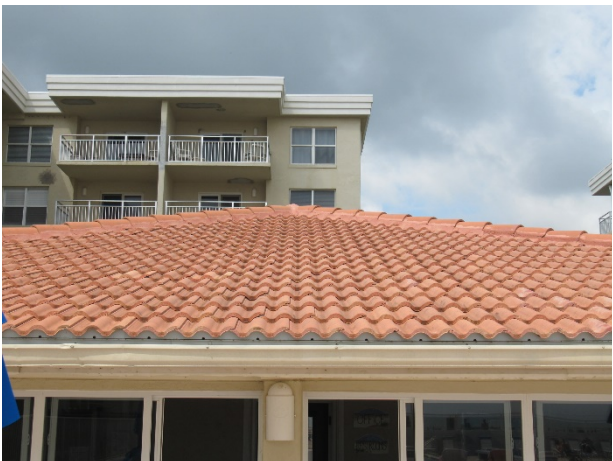
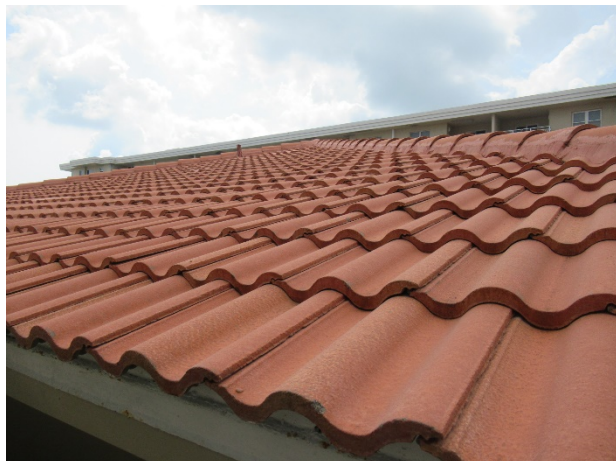
Condition: The roofs are in good to fair overall condition based on our visual inspection from the ground. Management does not report a history of leaks

Typical concrete tile roof

Expenditure Detail Notes: Expenditure timing and costs are depicted in the **Reserve Expenditures** table in Section 3. Despite the difference in useful lives of the two roof types, we depict replacement of the modified bitumen roof in conjunction with the concrete tile roofs due to its lesser age.

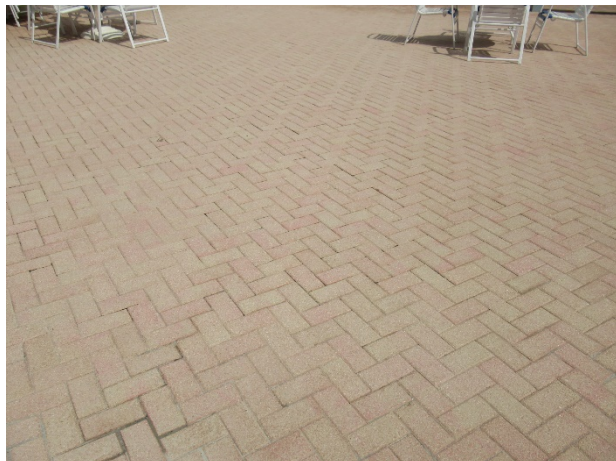
Condition: Unsatisfactory. Management informs us that the Association intends to replace the pavers in approximately 2026 and will apply a sealer to the pavers in approximately 2023.

Pool deck pavers

- Annually:
 - Inspect and repair settlement, trip hazards and significant paver spall
 - Reset and/or reseal damaged pavers as necessary
 - Periodically clean and remove overgrown vegetation as needed

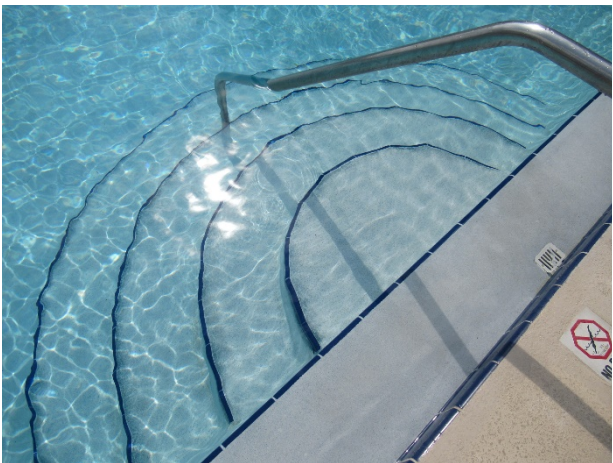
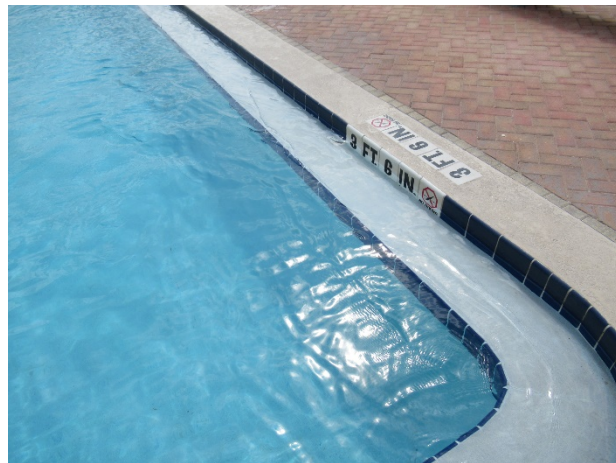
History: The plaster finishes were replaced in approximately 2015 and the tile is of unknown age. The Association plans to replace the tile in 2022.

Condition: Good to fair overall

Plaster and tile finishes

Expenditure Detail Notes: Expenditure timing and costs are depicted in the **Reserve Expenditures** table in Section 3. We recommend the Association budget for full tile replacement every other plaster replacement event. Removal and replacement of the finish provides the opportunity to inspect the pool structures and to allow for partial repairs of the underlying concrete surfaces as needed. To maintain the integrity of the pool structures, we recommend the Association budget for the following:

- Removal and replacement of the plaster finishes
- Partial replacements of the scuppers and coping as needed
- Replacement of tiles as needed
- Replacement of joint sealants as needed
- Concrete structure repairs as needed
