**SEA COAST  
MANAGEMENT NO. 2., INC.  
STRUCTURAL INTEGRITY RESERVE  
STUDY**

**For 30-Year Projection Period: FY 2023 through FY 2053**

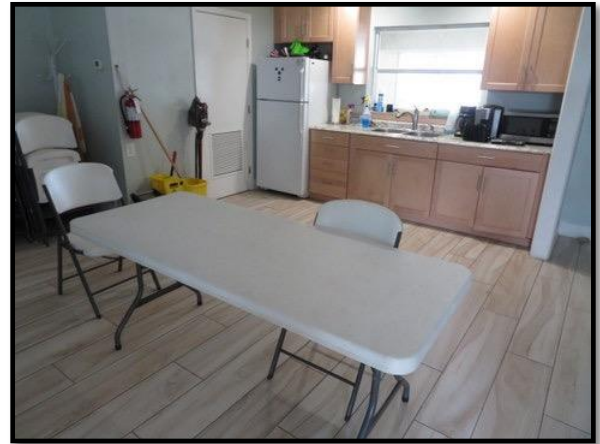
Figure 2 - Furniture

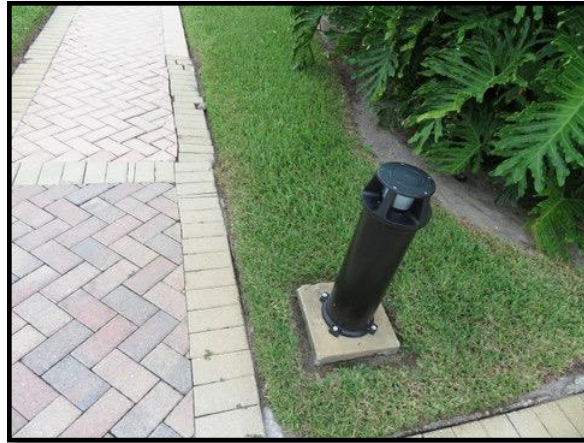
Figure 1

The Association maintains 22 bollard light fixtures located along the sidewalks. The bollards are in satisfactory operational condition at an unknown age. These bollards have an anticipate useful life of up to 20 years. Based on the condition, the Association should budget for their replacement

by 2030 and again by 2050. Interim replacement of light bulbs and/or fixtures should be funded through the operating budget on an as needed basis.
