Revised
FULL RESERVE STUDY

**Sea Coast
Management No. 2, Inc.**

New Smyrna Beach, Florida
Inspected - July 23, 2021
Revised - December 13, 2021

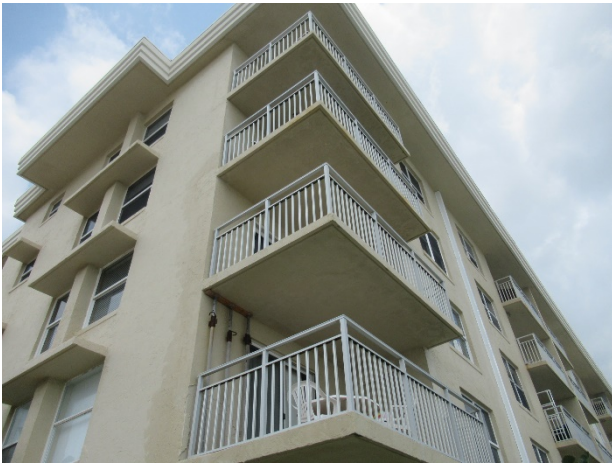
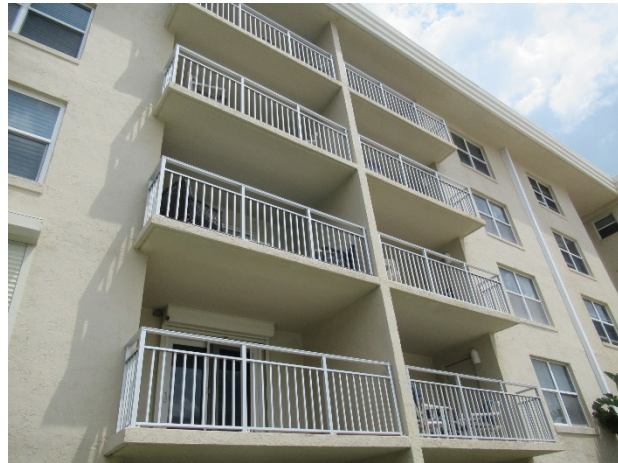
Condition: The balconies and breezeways are currently undergoing repairs, waterproof coating applications and paint finish applications with some areas yet to be repaired. We note significant spall at one balcony at the east side of the building and various cracks and rust stains at the balconies and breezeways that are yet to be repaired. Management informs us that the east and south-east face of the building, where the balconies are located, receive more ocean spray and require more extensive concrete repairs than the other areas of the building where the breezeways are located.

Typical balconies

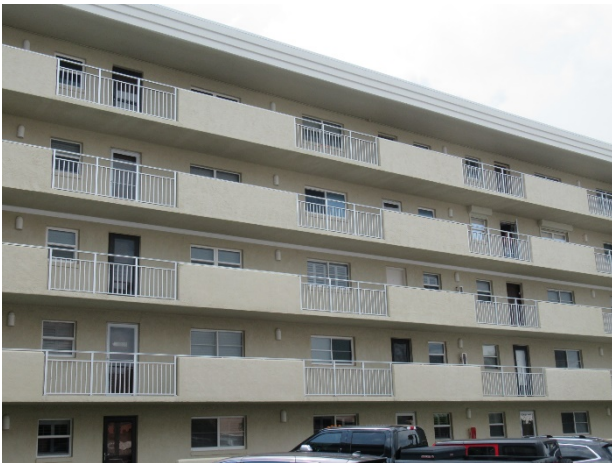
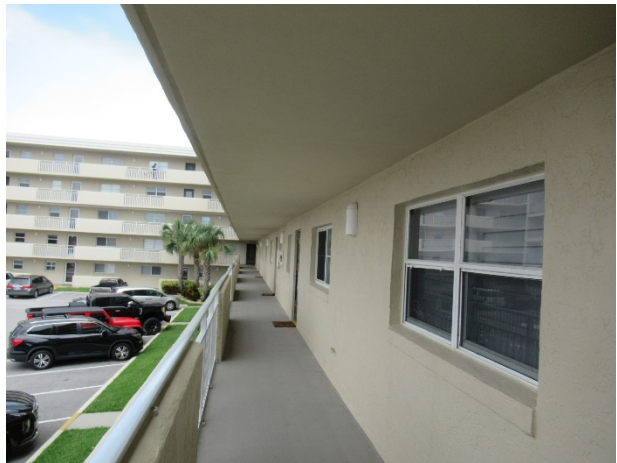
Typical breezeways

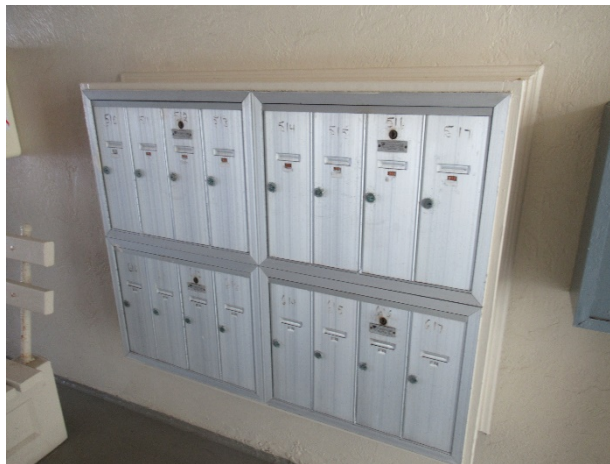
Condition: Reported unsatisfactory

Typical mailboxes

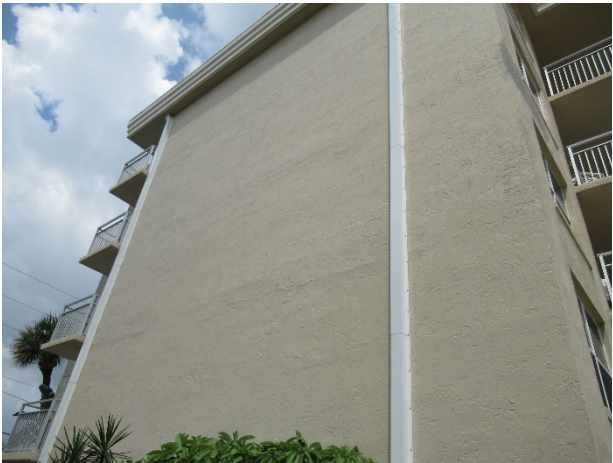
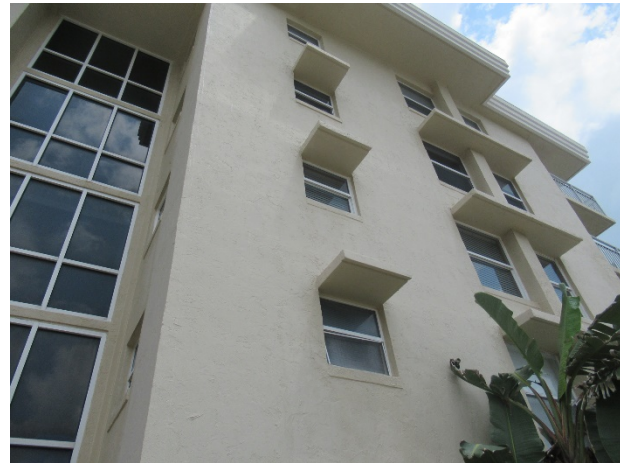
Condition: Repairs ongoing

Stucco overview

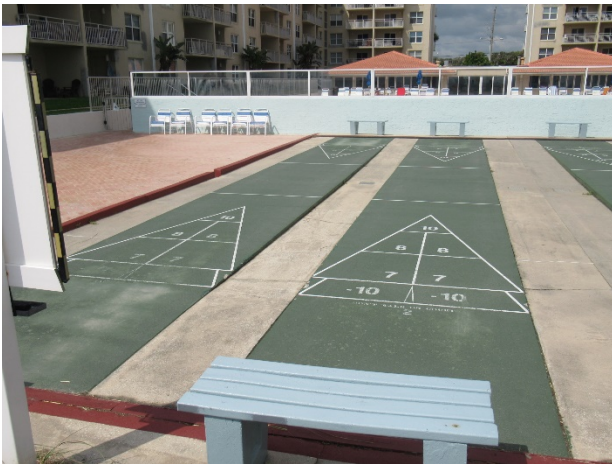
Condition: Fair overall with areas of deterioration

Shuffleboard courts overview

History: Management informs us that the Association will conduct a color coat application only to the shuffleboard courts in 2022.

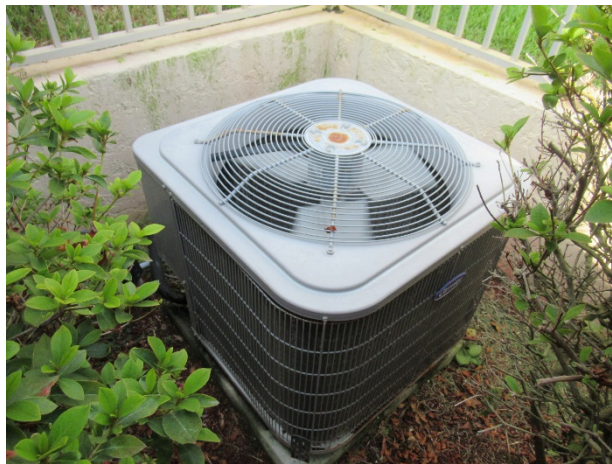
History: One condenser replaced in 2014 and another in 2017

Condition: Reported satisfactory

Remote condenser

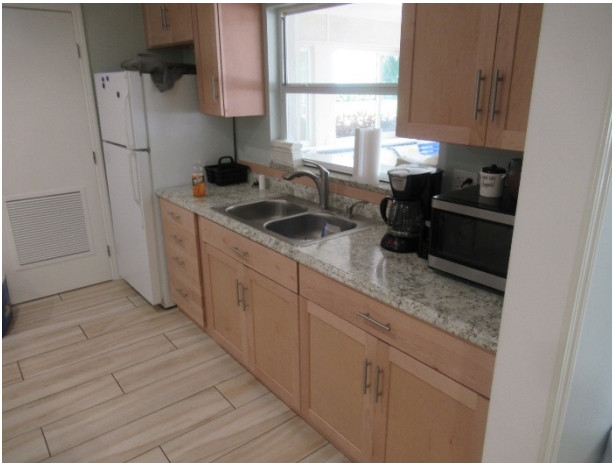
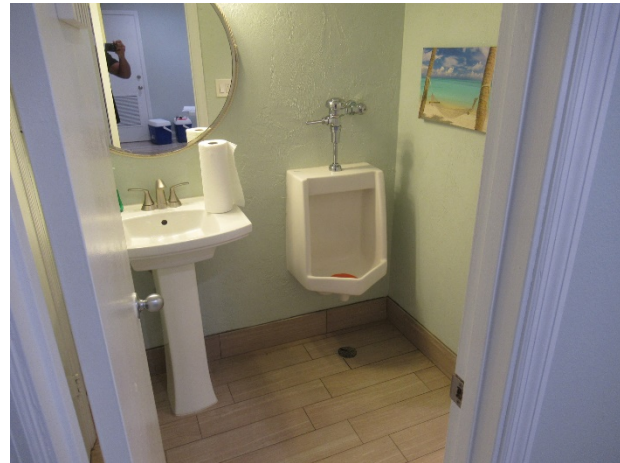
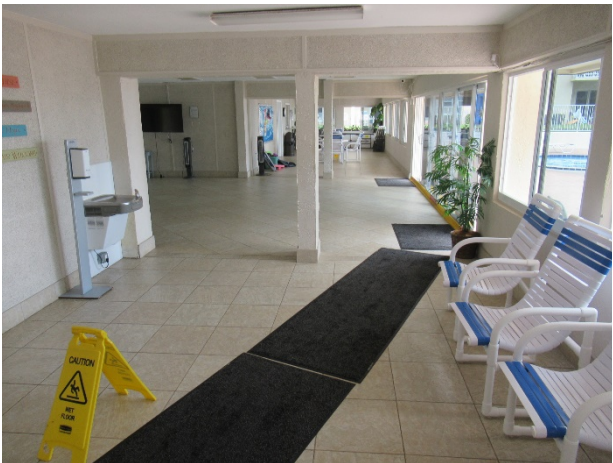
Condition: Good overall

Clubhouse kitchen

Typical clubhouse restroom

Clubhouse common area overview

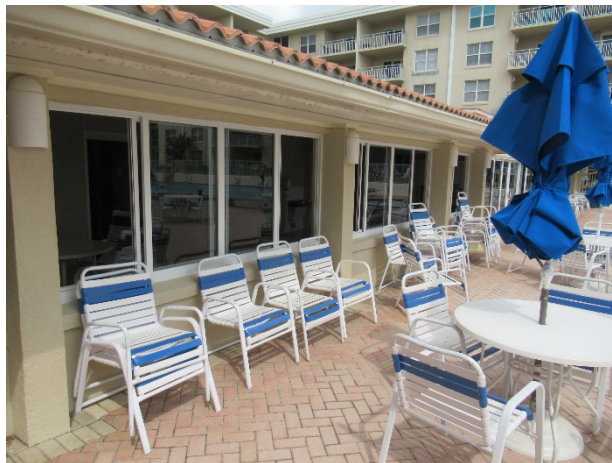
History: Mostly replaced in 2011

Condition: Good overall

Clubhouse windows

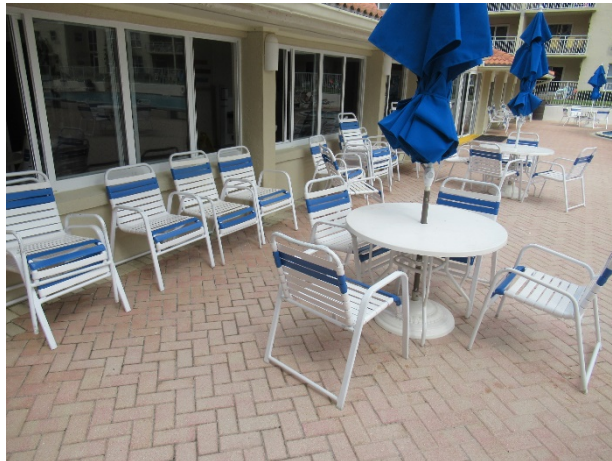
Condition: Good to fair overall

Pool furniture

Expenditure Detail Notes: Expenditure timing and costs are depicted in the **Reserve Expenditures** table in Section 3. We recommend interim re-strapping, refinishing, cushion replacements, reupholstering and other repairs to the furniture as normal maintenance to maximize its useful life.

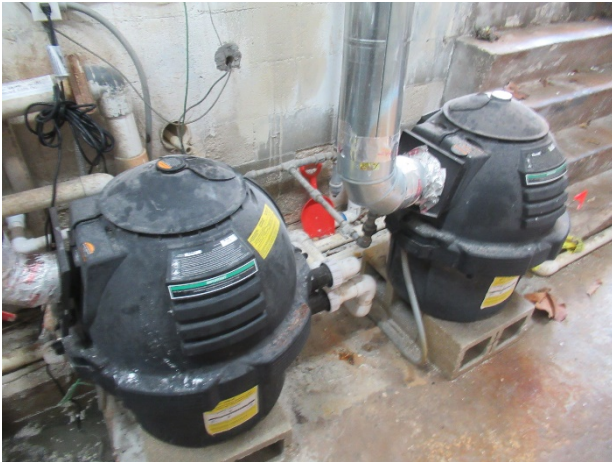
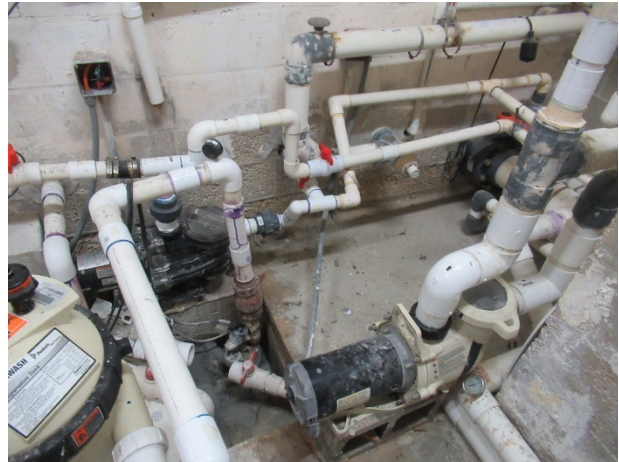
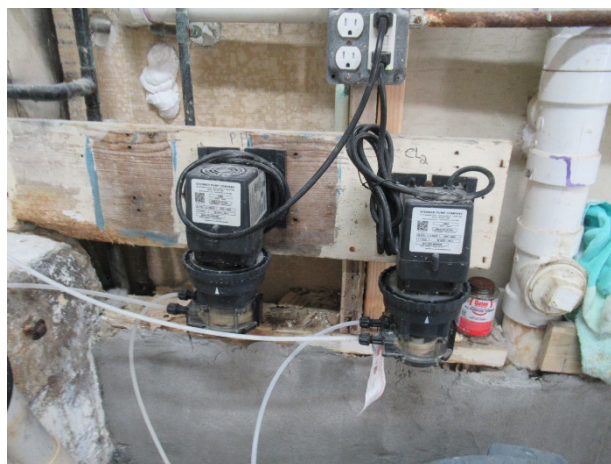
Condition: Reported satisfactory

Mechanical equipment

Preventative Maintenance Notes: We recommend the Association maintain a maintenance contract with a qualified professional and follow the manufacturer's specific recommended maintenance and local, state and/or federal inspection guidelines.
